Field Services Report:

Vibration Analysis of 2500 hp York Chiller

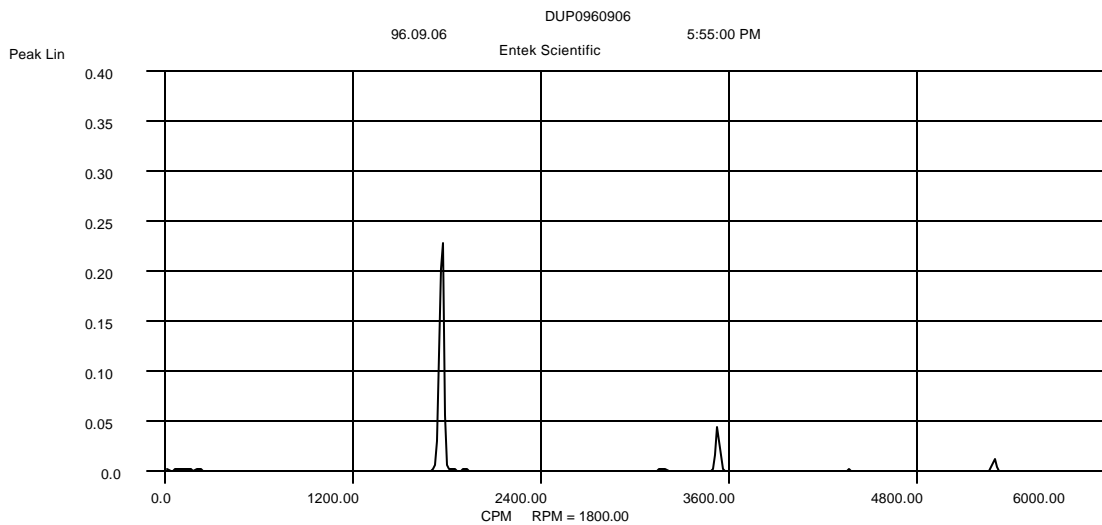
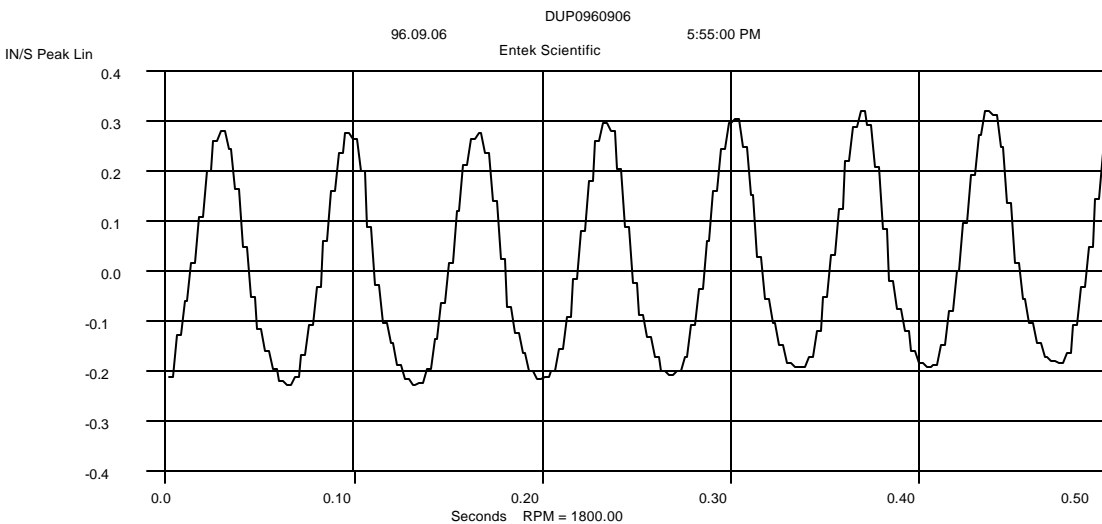
Figure 2: Vibration Spectrum Before Tightening Foot

Vibration data recorded by plant personnel showed a steady increase in vibration during the 3 days prior to this analysis. The highest vibration recorded was in the vertical direction. The time wave forms recorded by plant personnel displayed attributes common to mass unbalance and/or unrestrained looseness.

Description: MACHINE: 2500 HP YORK POINT ID: 14 TRAIN: COMPRESSOR Point: 00014 2 Vertical

Description: MACHINE: 2500 HP YORK POINT ID: 13 TRAIN: COMPRESSOR Point: 00013 2 Vertical

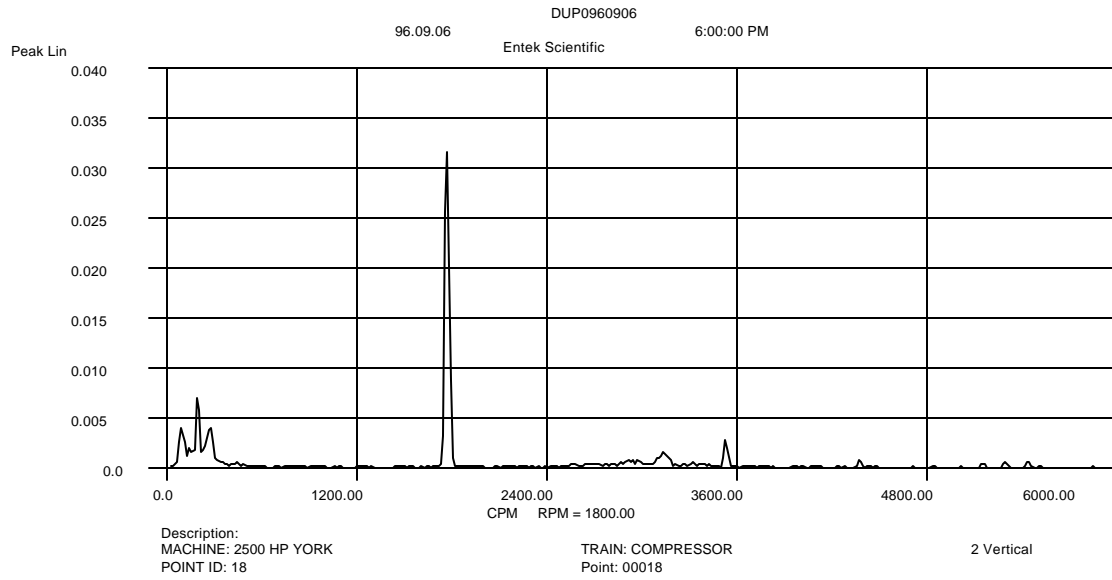
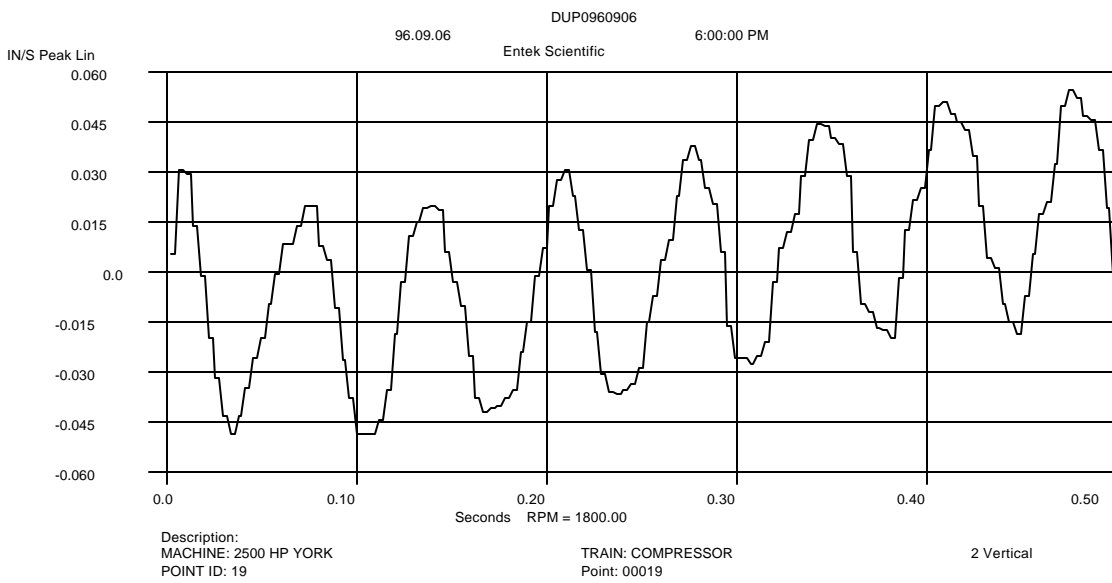
Figure 3: Vibration Spectrum After Tightening Foot

The maximum vibration level recorded on the motor was 0.06 ips and is classified as GOOD by the IRD General Machinery Vibration Severity Chart.

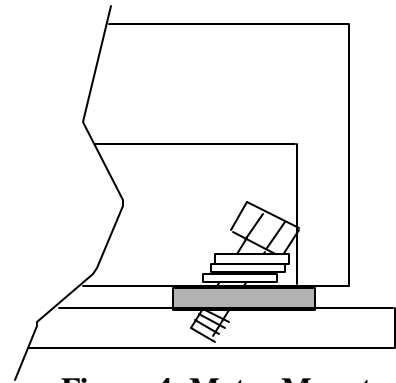
Figure 4: Motor Mount

The high vibration was caused by the loose motor mount. Observation revealed the mounting cap screw was bottomed out and not making full head contact. A shim had to be placed under the cap screw head to facilitate tightening. See figure 4.

If the motor mounting bolts are not applying the proper clamping force the motor can move and cause the shims under the foot to propagate out from under the foot. This in turn will allow the motor to vibrate excessively in the vertical direction at the location of the unsupported foot.

All motor mounting fasteners should be checked for proper clamping and fit. Consideration should be given to modifying the present method of mounting the motor if proper fit and clamping can not be achieved.
