Vibration Analysis and Balancing of Cooling Tower Cells

Abstract

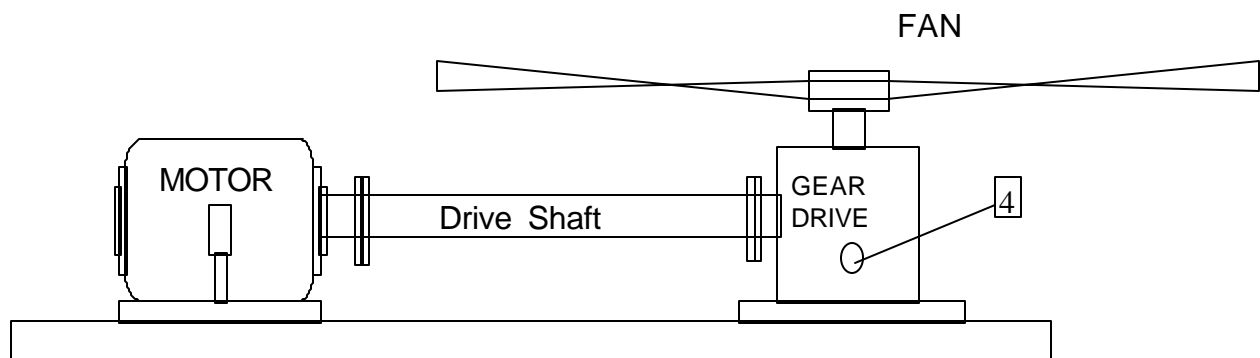
Figure 1: Machine Configuration

A vibration amplitude spectra was taken on the fans using a low frequency transducer (see equipment section in appendix) mounted to the gear box in the radial direction (90° to the drive shaft). This is shown as position "4" in Figure 1. In all cases, vibration levels were high (pk/pk mils 17, 25, 32, 60) and the time wave form along with the high spike in the spectrum at the running speed of the fan indicated that the fans were unbalanced.
