Field Services Report

Alignment of Ball Mill Using Optical and LASER Methods

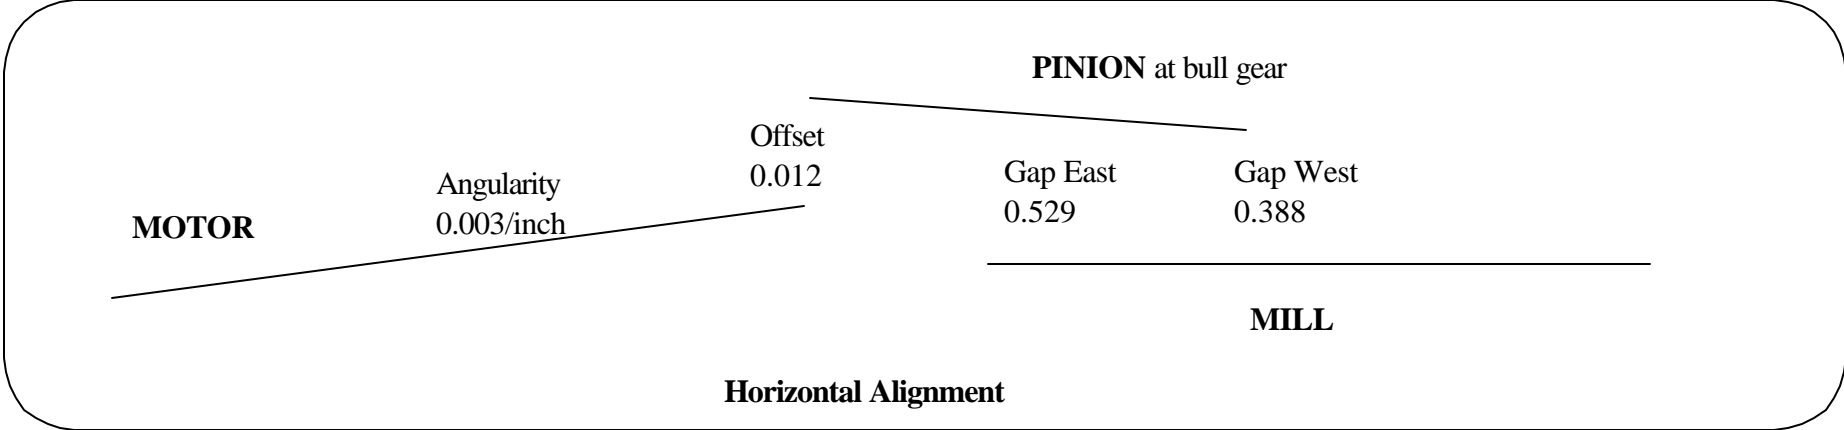
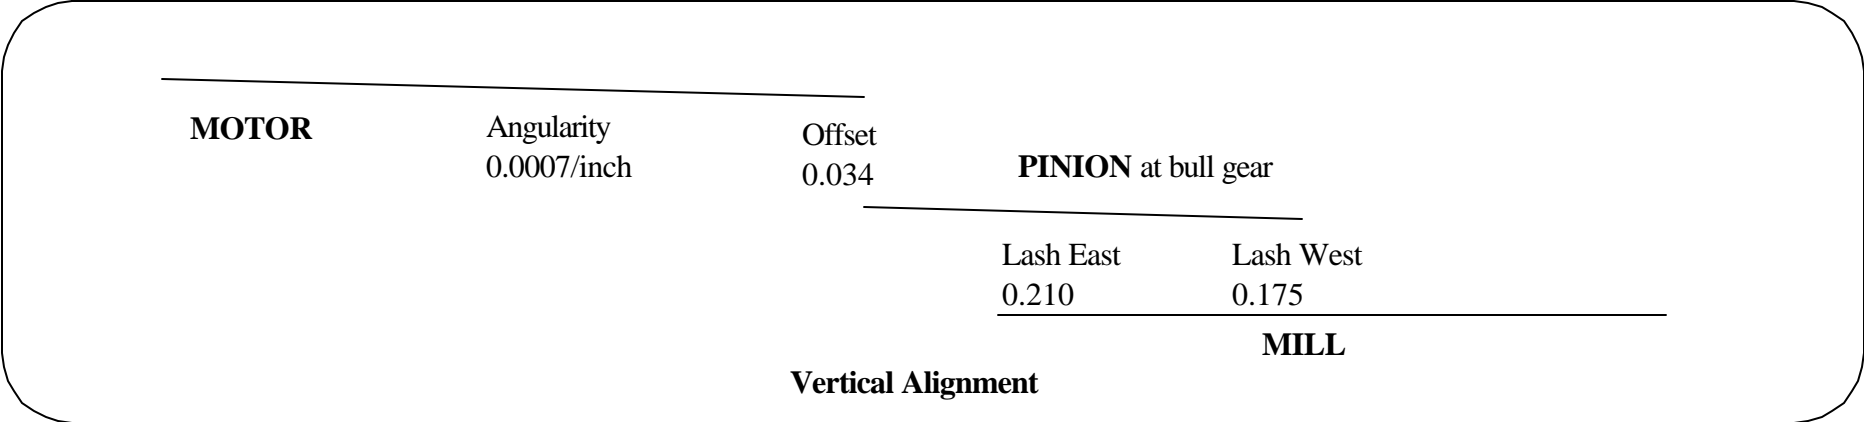
Ball Mill As Found Alignment 99/11/29

The relative elevation of the mill bearings was measured with two setups, one at each bearing, with a common benchmark reference.

The inlet (east) bearing elevation was 1.771. The outlet (west) bearing elevation was 1.790.

The as found alignment of the pinion to the bull gear was 0.141 inch difference east to west. The back lash was 0.035 east to west. The alignment across the clutch was 0.012 inch offset with 0.003 inch/inch angularity in the horizontal direction and 0.034 inch offset with 0.0007 inch/inch angularity in the vertical direction. An elevation difference of 0.020 inch was measured from the mill bearings.

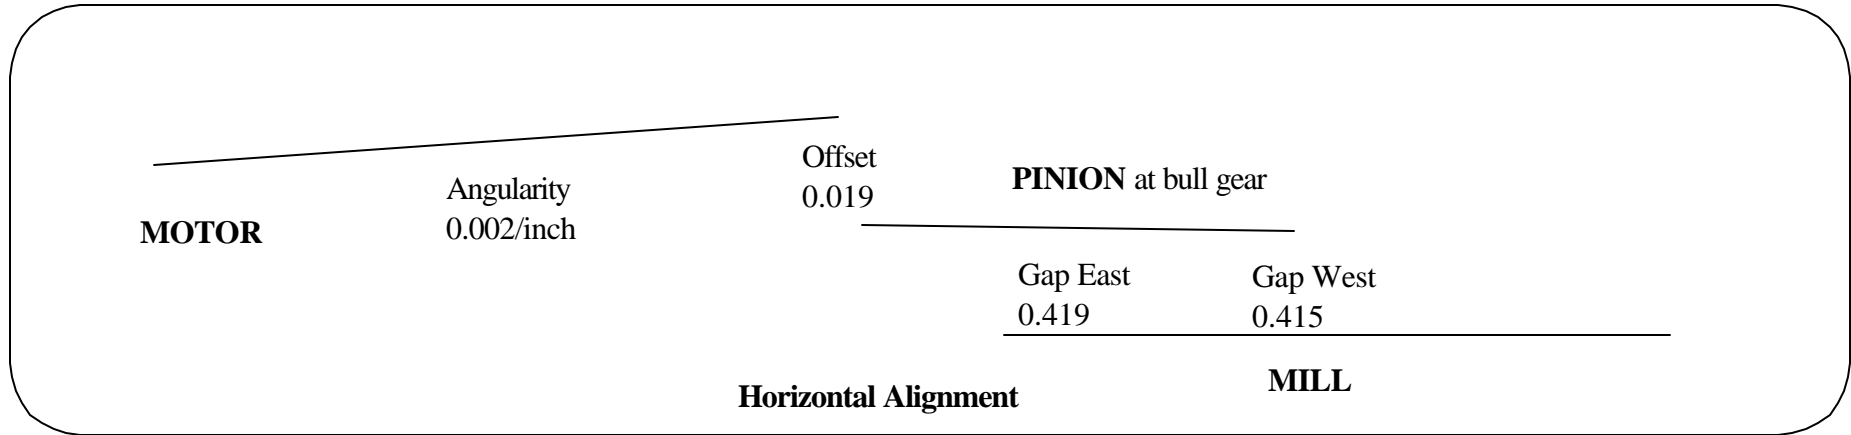
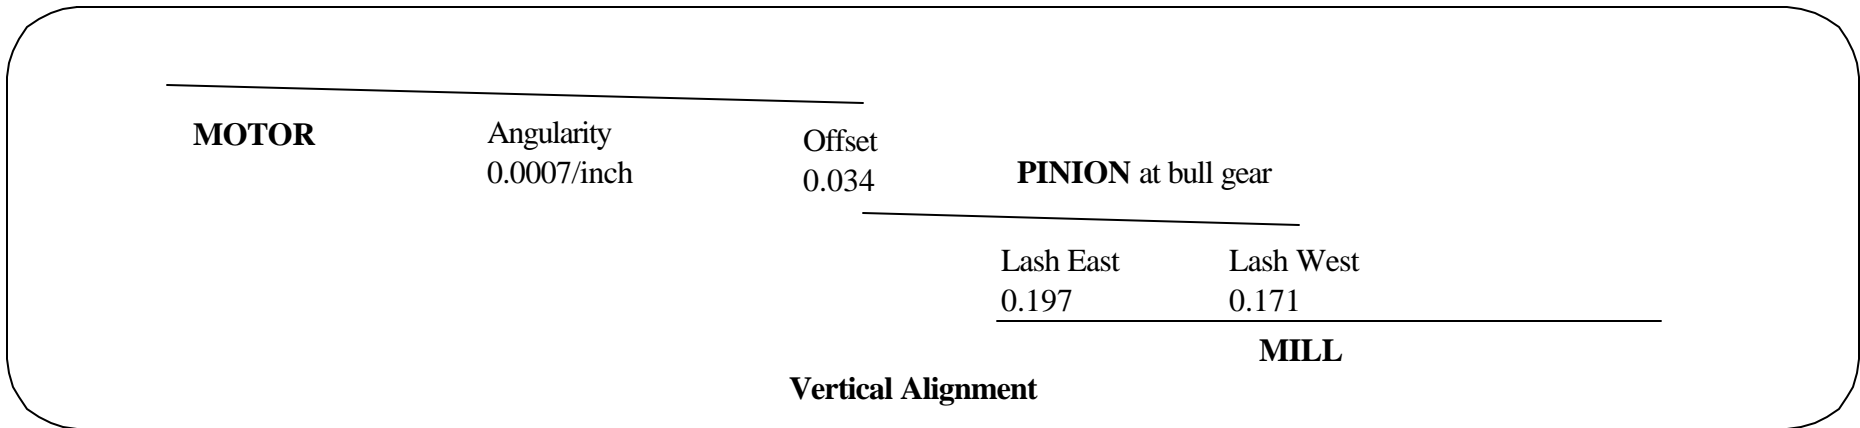
Ball Mill After 0.040 Pinion Move 99/12/09

A 0.040 inch move south of the west pinion bearing resulted in the above relative alignment positions.
