## **Vibration Analysis of Cooling Tower Cell D**

### Abstract

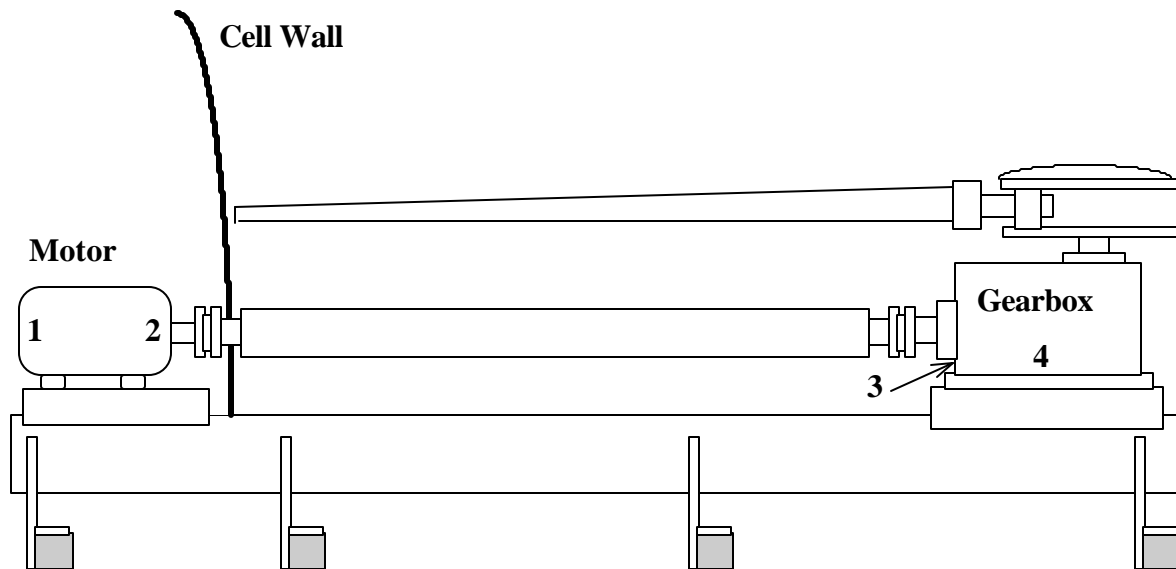
**Figure 1: Machine Configuration**

A low frequency transducer was placed in the radial direction on the gearbox at position 4 (see figure 1), and a standard accelerometer was placed in axial direction on the gearbox at position 3 (see figure 1). Both transducers utilized a magnetic base.

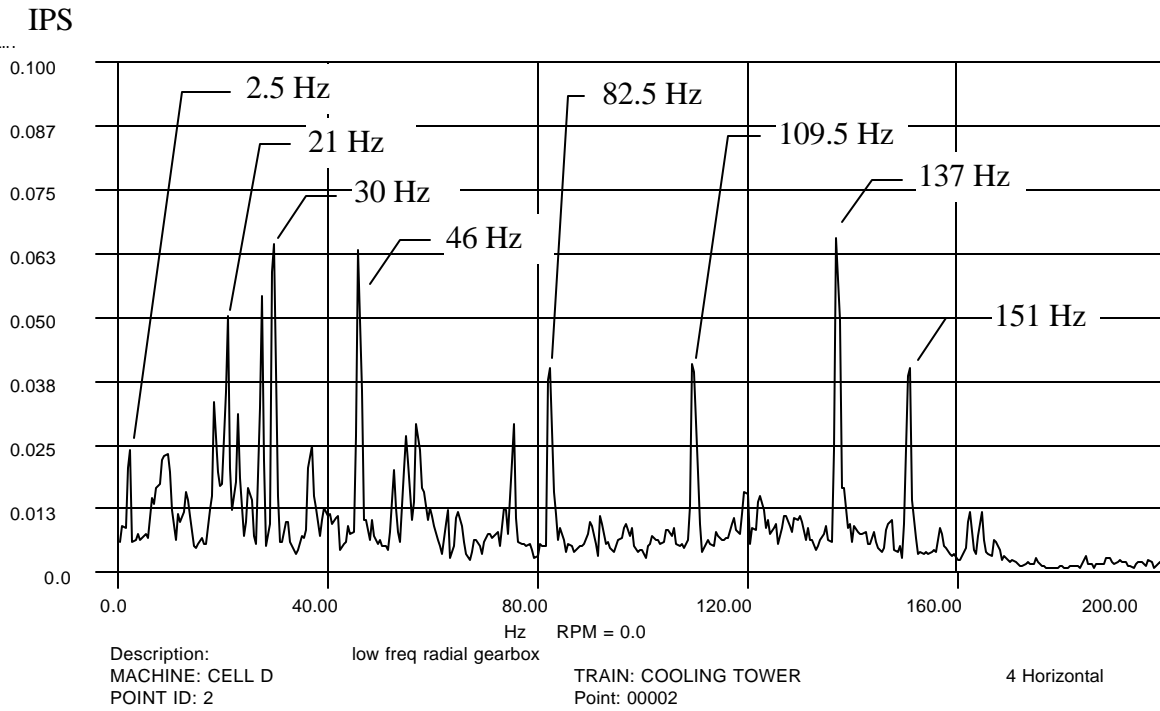
**Figure 2: Vibration Spectrum D Cell (Low Frequency Transducer)**

The low frequency spectrum recorded on cell D (see figure 2/pg. 3) shows that the running speed of the fan (2.5 Hz) is low in amplitude compared to other frequencies in the spectrum. The dominant frequencies are the running speed of the motor (30 Hz), 2X the blade pass (46 Hz), and 5X the BPF1 on the lower bearing in the gearbox (137 Hz).

The major cause of vibration on the D cell of cooling tower PB-3302 is not unbalance. It is probably due to loose venturi panels and structural components, gearbox bearing defects, and sympathetic vibration excited by the other cells. All of these vibrations combined generated an overall vibration level of approximately 0.30 ips on the gearbox in the radial direction.

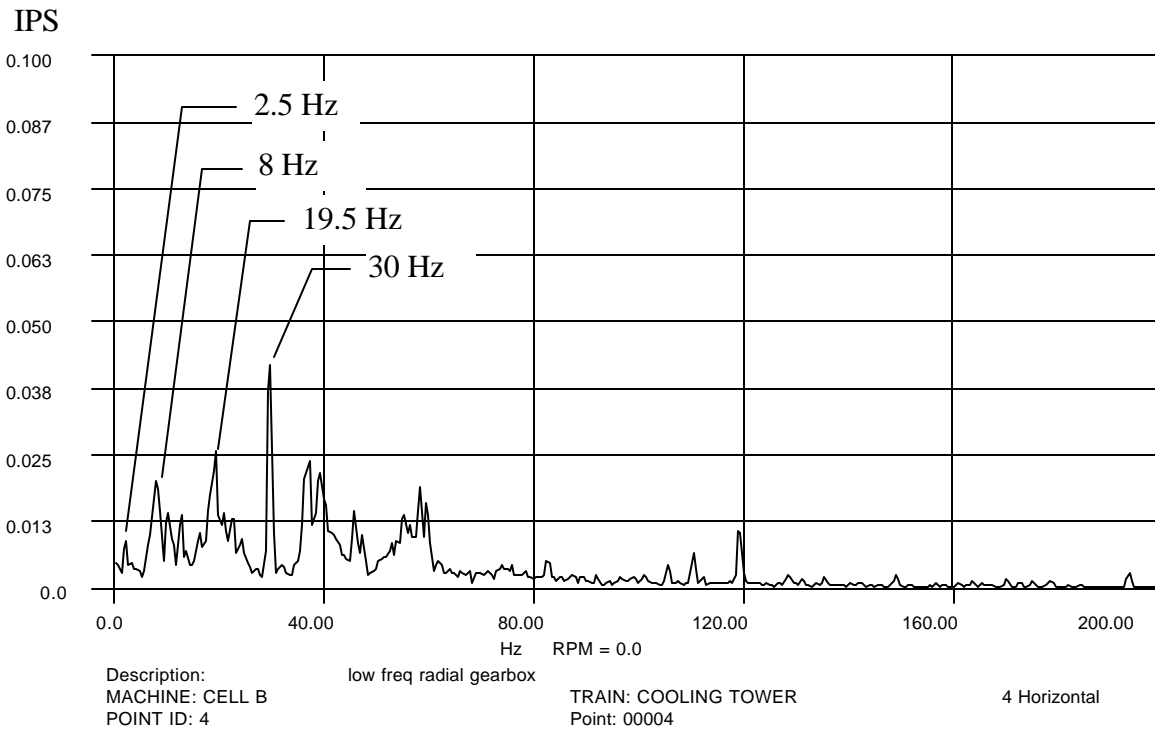
**Figure 3: Vibration Spectrum B Cell (Low Frequency Transducer)**

In comparison the D cell spectrums show peaks associated with the gear box defect frequencies, the B cell does not. The overall vibration amplitudes are similar. The highest vibrations recorded on both cells were on the motor.

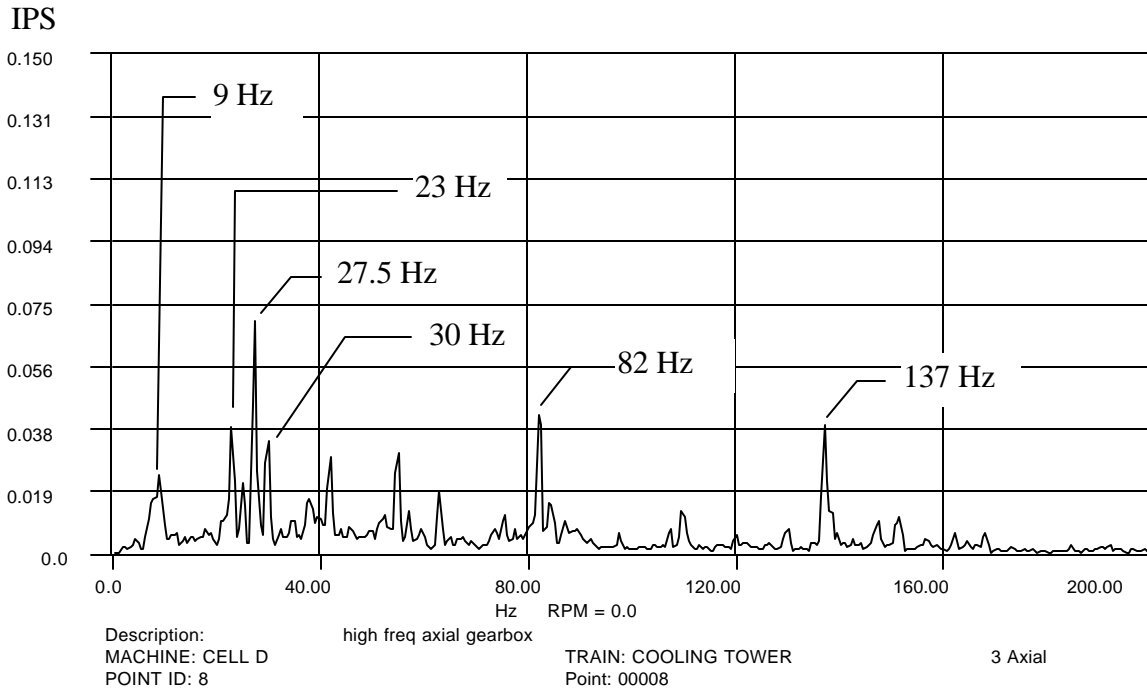
**Figure 4: Vibration Spectrum D Cell (High Frequency Transducer)**

The high frequency spectrum recorded on cell D (see figure 4/pg. 4 ) shows that the dominant frequencies are the BPF1 on the lower bearing in the gearbox (27.5 Hz), 3X the BPF1 on the lower bearing in the gearbox (82 Hz), and 5X the BPF1 on the lower bearing in the gearbox (137 Hz).

The loading of the lower thrust bearing should be verified to be within the bearing manufacturers published capacities.

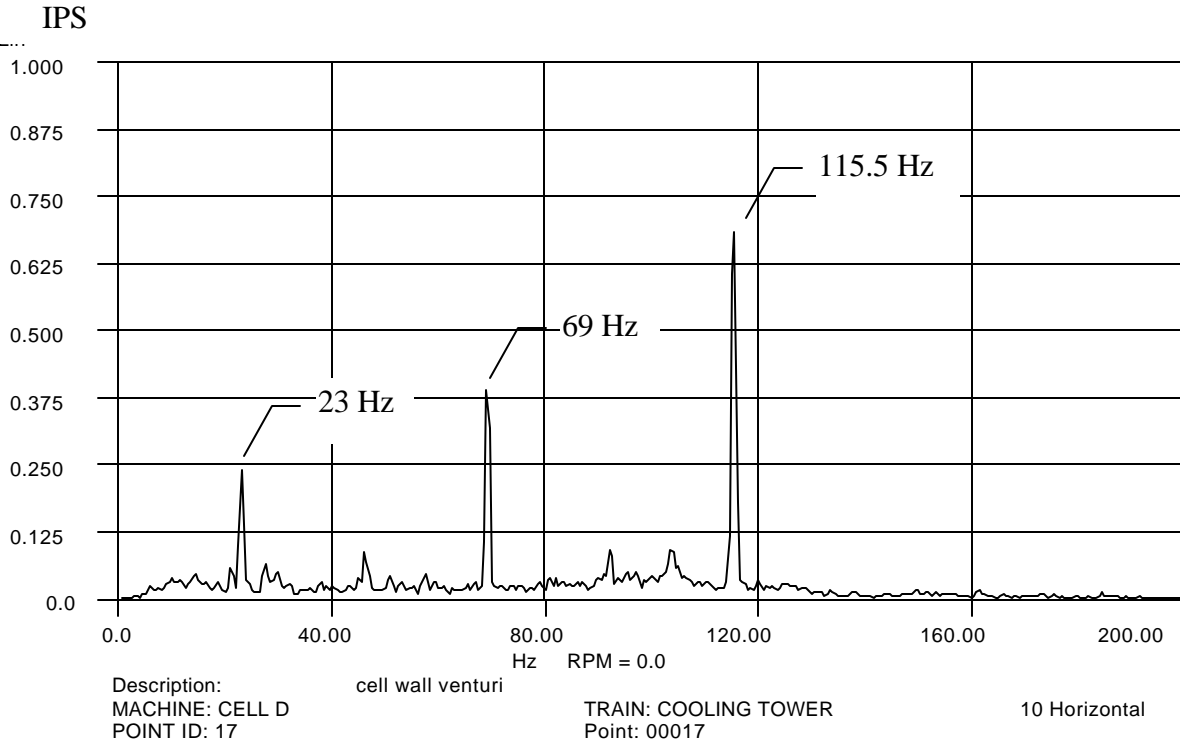
**Figure 6: Vibration Spectrum D Cell (Venturi Wall)**

The spectrum recorded on the venturi wall on cell D (see figure 6/pg. 5) shows the dominant frequencies are the blade pass and harmonics. The amplitude of 115.5 Hz is greater than 0.50 ips.

The loose venturi panel fasteners should be tightened and any missing fasteners replaced.

The venturi panels should be inspected and repaired as necessary.
