# Field Services Report

## Vibration Analysis: Rental Boiler FD Fan

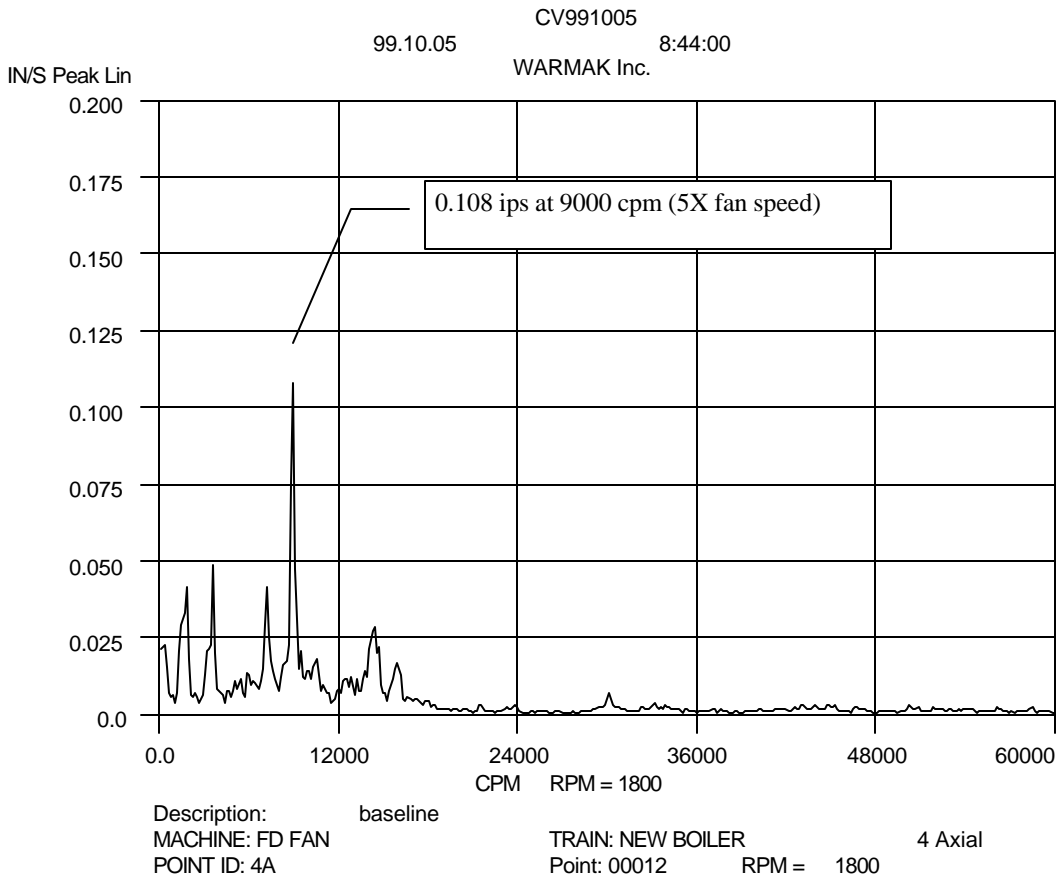
Position	Amplitude	Frequency	Date
1H	0.018	1800.00	99.10.05
1V	0.012	3600.00	99.10.05
1A	0.034	1500.00	99.10.05
2H	0.014	1800.00	99.10.05
2V	0.008	1800.00	99.10.05
2A	0.011	1800.00	99.10.05
3H	0.071	1800.00	99.10.05
3V	0.083	3600.00	99.10.05
3A	0.050	3600.00	99.10.05
4H	0.027	7200.00	99.10.05
4V	0.032	9000.00	99.10.05
<b>4A</b>	<b>0.108</b>	<b>9000.00</b>	<b>99.10.05</b>

**Spectrum of highest amplitude with dampers set at 45% fresh, 60% recirculation**

The major cause of vibration is from aerodynamic instabilities at full open dampers and bearing defects. Some high frequency broad based noise was observed in the spectral data. The highest vibration recorded with the dampers at half was 0.11 ips at 9000 cpm in the axial direction (5X fan speed).

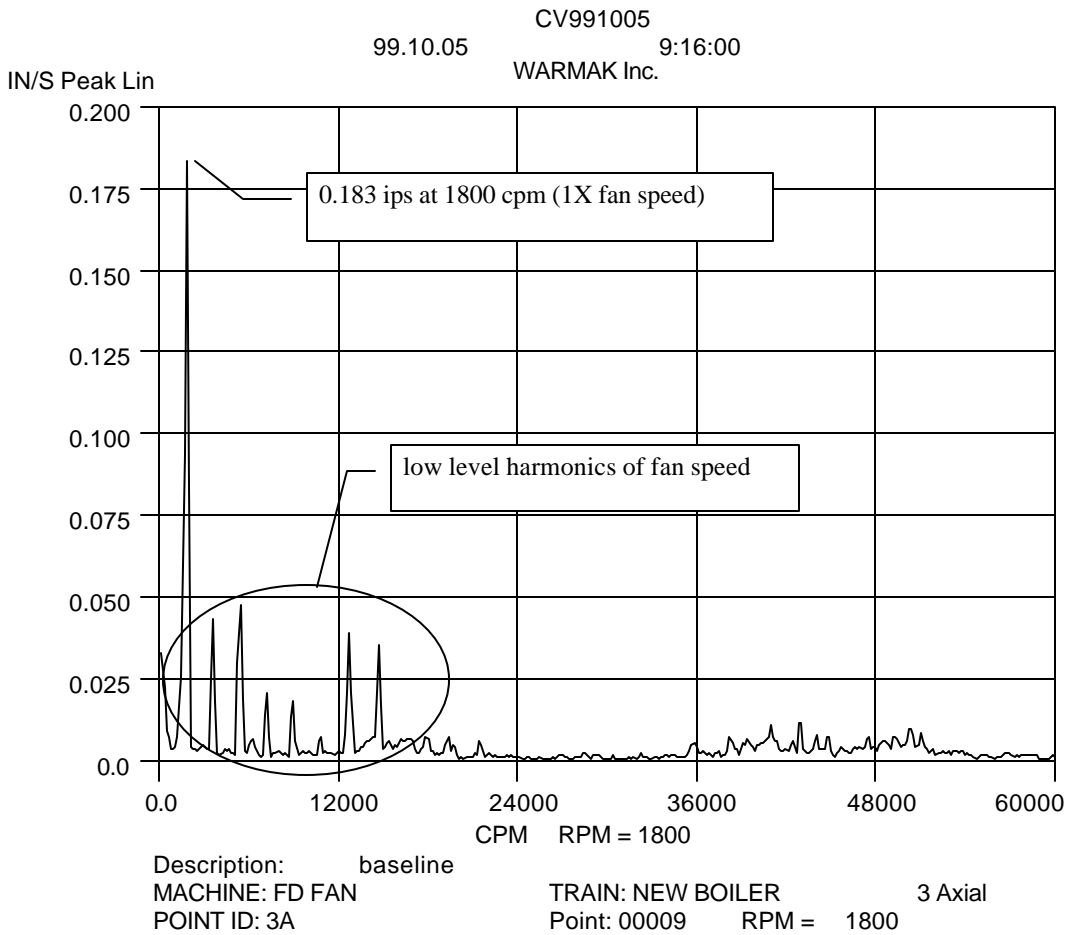
Position	Amplitude	Frequency	Date
1H	0.024	1800.00	99.10.05
1V	0.030	1800.00	99.10.05
1A	0.096	1800.00	99.10.05
2H	0.015	1800.00	99.10.05
2V	0.005	1800.00	99.10.05
2A	0.005	1800.00	99.10.05
3H	0.092	1800.00	99.10.05
3V	0.079	3600.00	99.10.05
<b>3A</b>	<b>0.183</b>	<b>1800.00</b>	<b>99.10.05</b>
4H	0.029	1800.00	99.10.05
4V	0.018	1800.00	99.10.05
4A	0.118	1800.00	99.10.05

**Spectrum of Highest Amplitude with dampers set at 100% fresh, 80% recirculation**

The maximum vibration level recorded was 0.183 ips at 1800 cpm from the #3 motor bearing housing, in the axial direction and is classified as slightly rough.
