# Field Services Report

## Vibration Measurement and Analysis of Fin Fan Coolers

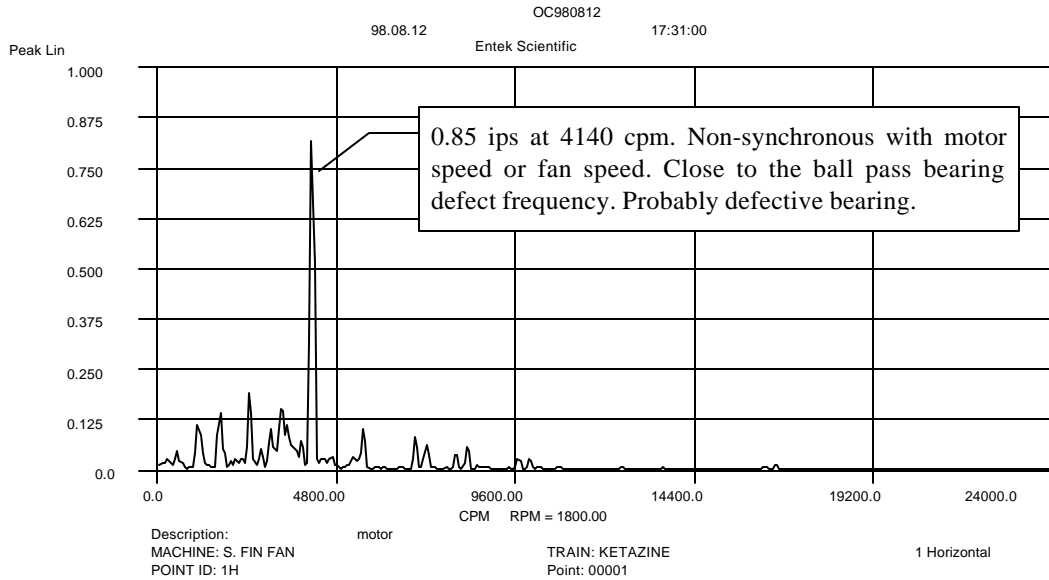
**Spectrum of Maximum Vibration from S. Fan Motor**

High vibration, 0.8 ips at 4140 cpm was recorded from the motor in the horizontal direction. The non-synchronous vibration could from a bad bearing.

High vibration, 0.8 ips at 1680 cpm was recorded from the motor in the axial direction. Some peaks were observed in other spectral data at 10X (1680 cpm) the belt speed of 168 cpm.

The bearings in the motor should be inspected and replaced if needed.

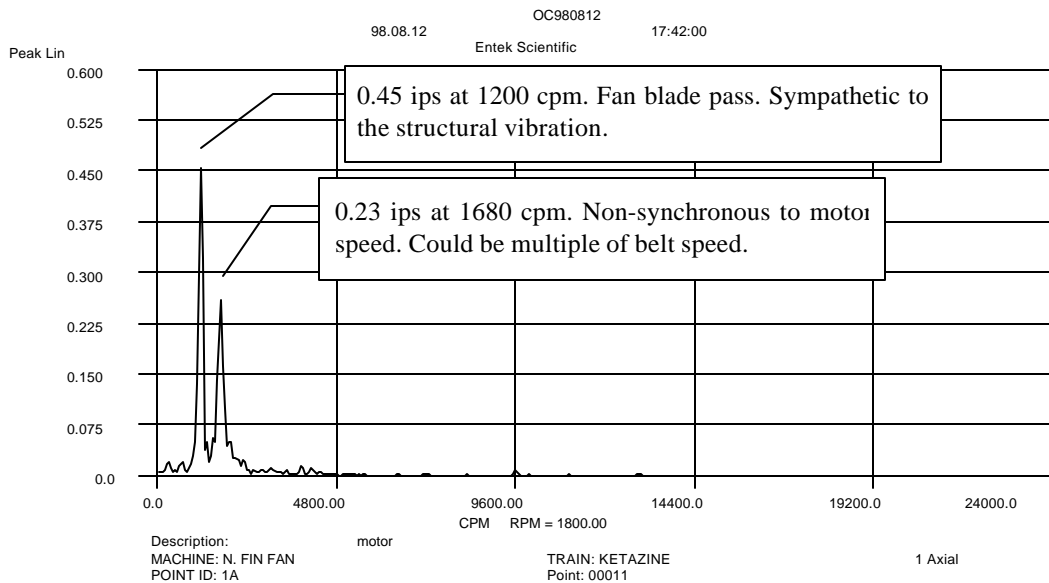
**Spectrum of Maximum Vibration from N. Fan Motor**

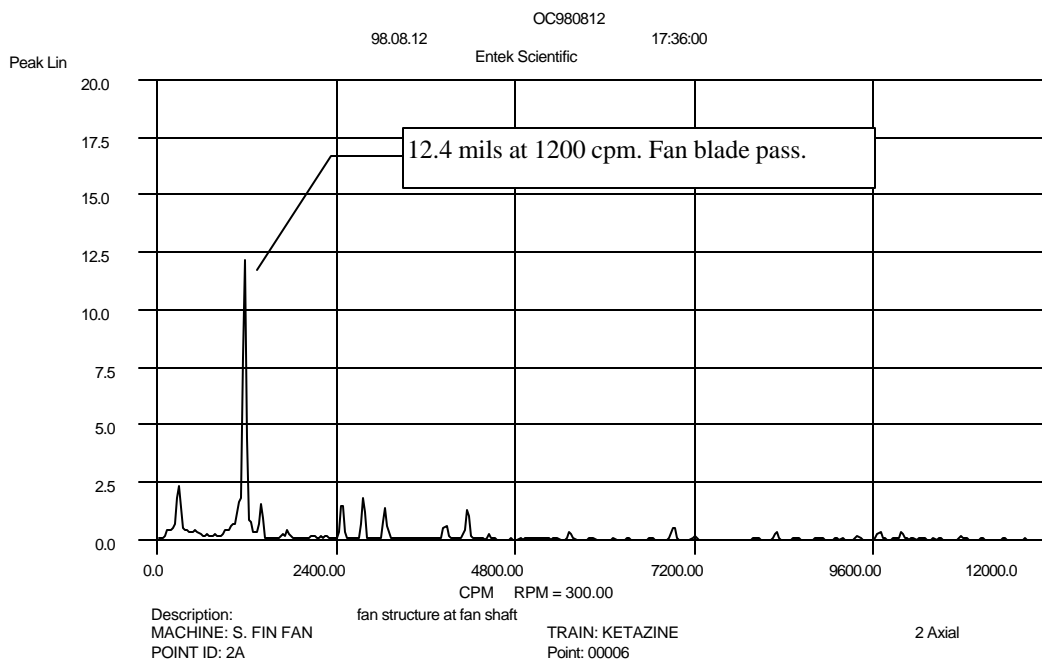
**Spectrum of Maximum Vibration from S. Fan Structure**

Both fans are probably operating near a structural resonance. The blade pass and a coupling between the two units are probably exciting the structure and causing the surging observed from both fans.

Consideration should be given to eliminating the surging phenomenon. This will increase the life and efficiency of the equipment.

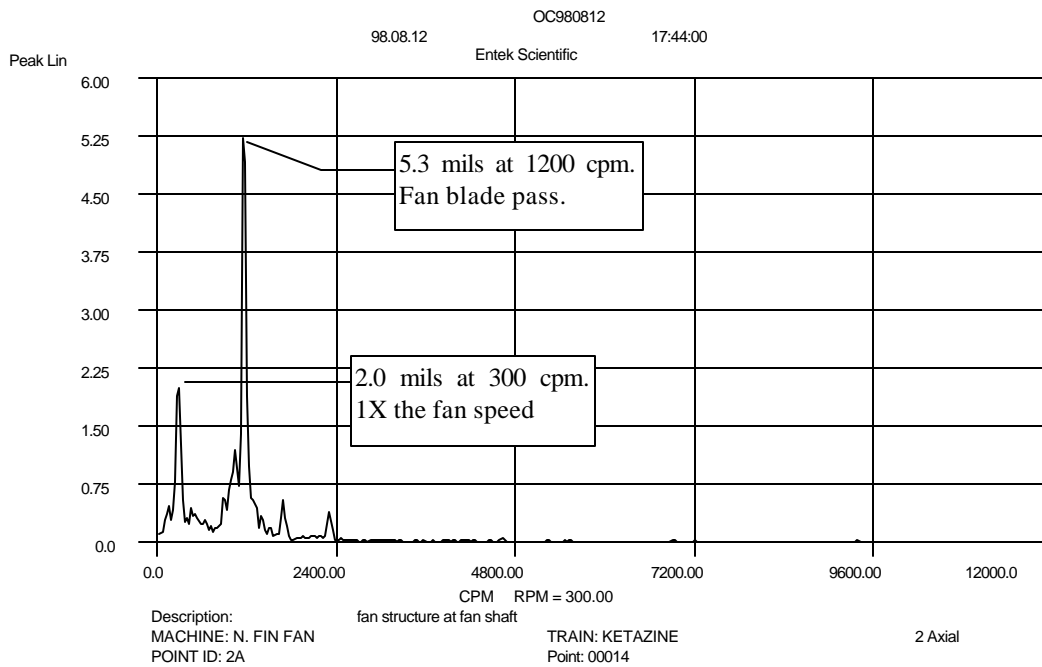
**Spectrum of Maximum Vibration from N. Fan Structure**

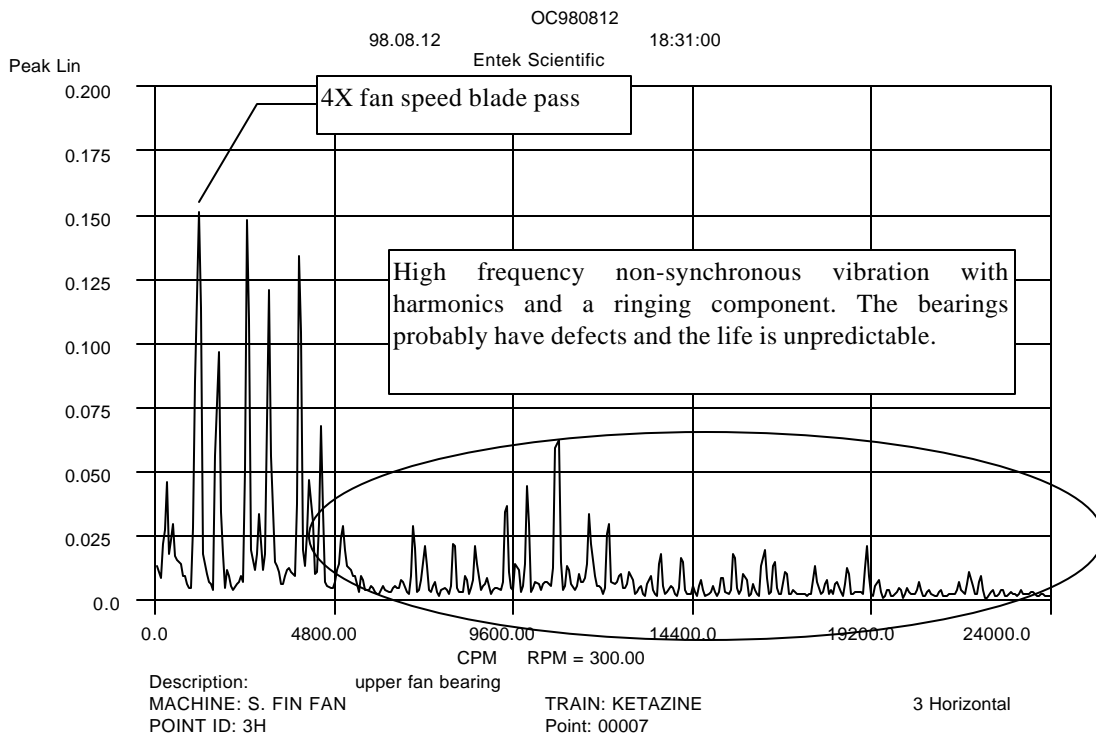
**Spectrum of Vibration from Bearing on S. Fan Shaft**

The fan bearings of the S. Fan are probably worn out. This may in part be from the surging of the structure. The spectral data observed could have been during a surge and the vibration levels seen were caused by the surge and not causing the surge.

The fan bearing on the S. Fan shaft should be replaced as soon as probable. The life is unpredictable.

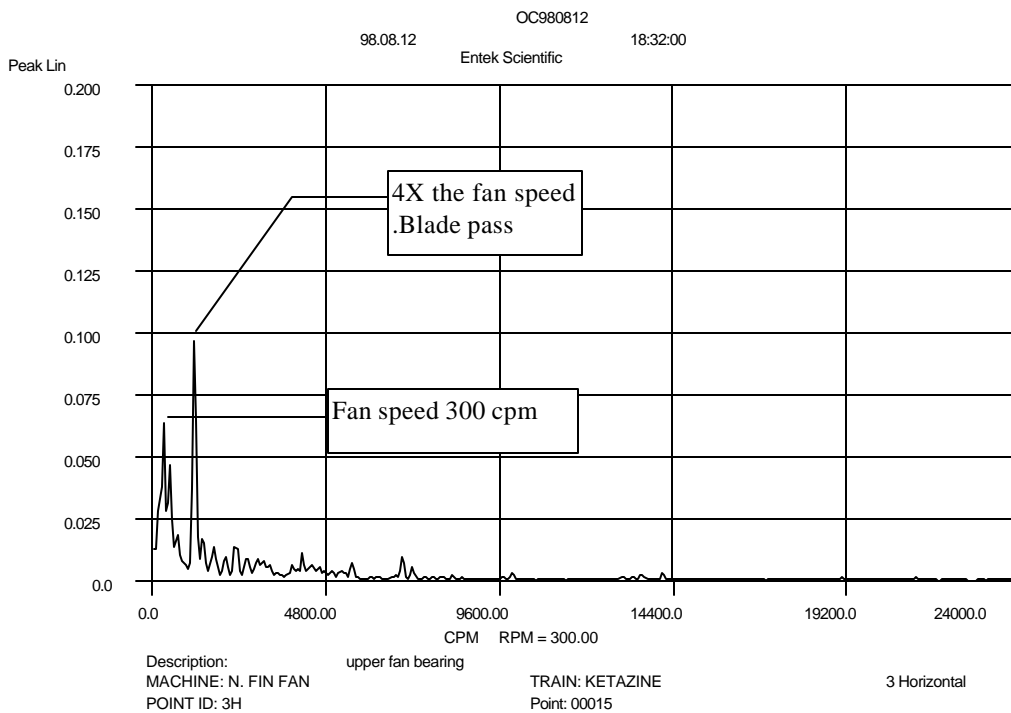
**Spectrum of Vibration from Bearing on N. Fan Shaft**

The bearings on the N. Fan do not display the same spectral properties as the S. Fan. This does not mean that the bearings of the N. Fan are not susceptible to the same problems.
