# Field Services Report

## LASER Alignment of Motor to Pump

WARMAK Inc. (WMK) was commissioned to align a horizontal motor/pump cooling tower unit. The unit is located at ground level in the facility. The coupling was changed from a gear type to a serpentine flex band type. The equipment was aligned to within manufacturer and industry standard tolerances using LASER methods. The nominal speed of equipment is 1200 rpm.

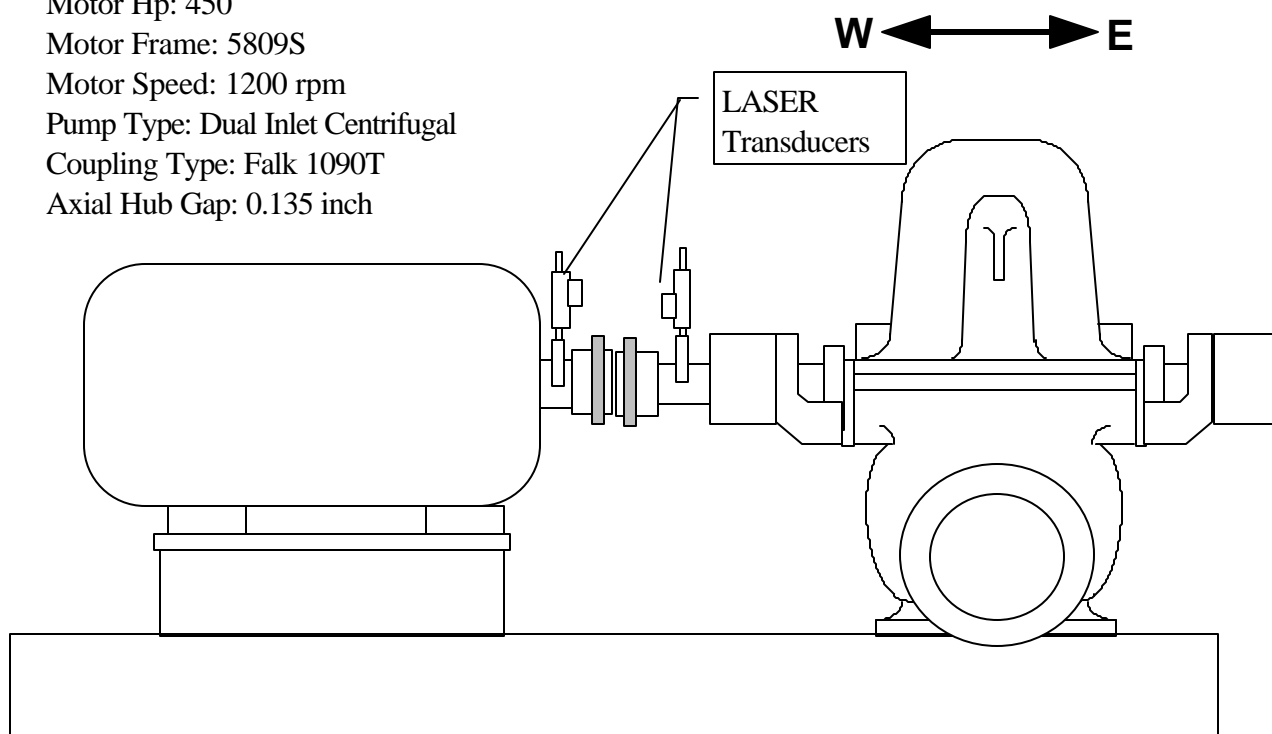
Motor Hp: 450

Motor Frame: 5809S

Motor Speed: 1200 rpm

Pump Type: Dual Inlet Centrifugal

Coupling Type: Falk 1090T

Axial Hub Gap: 0.135 inch

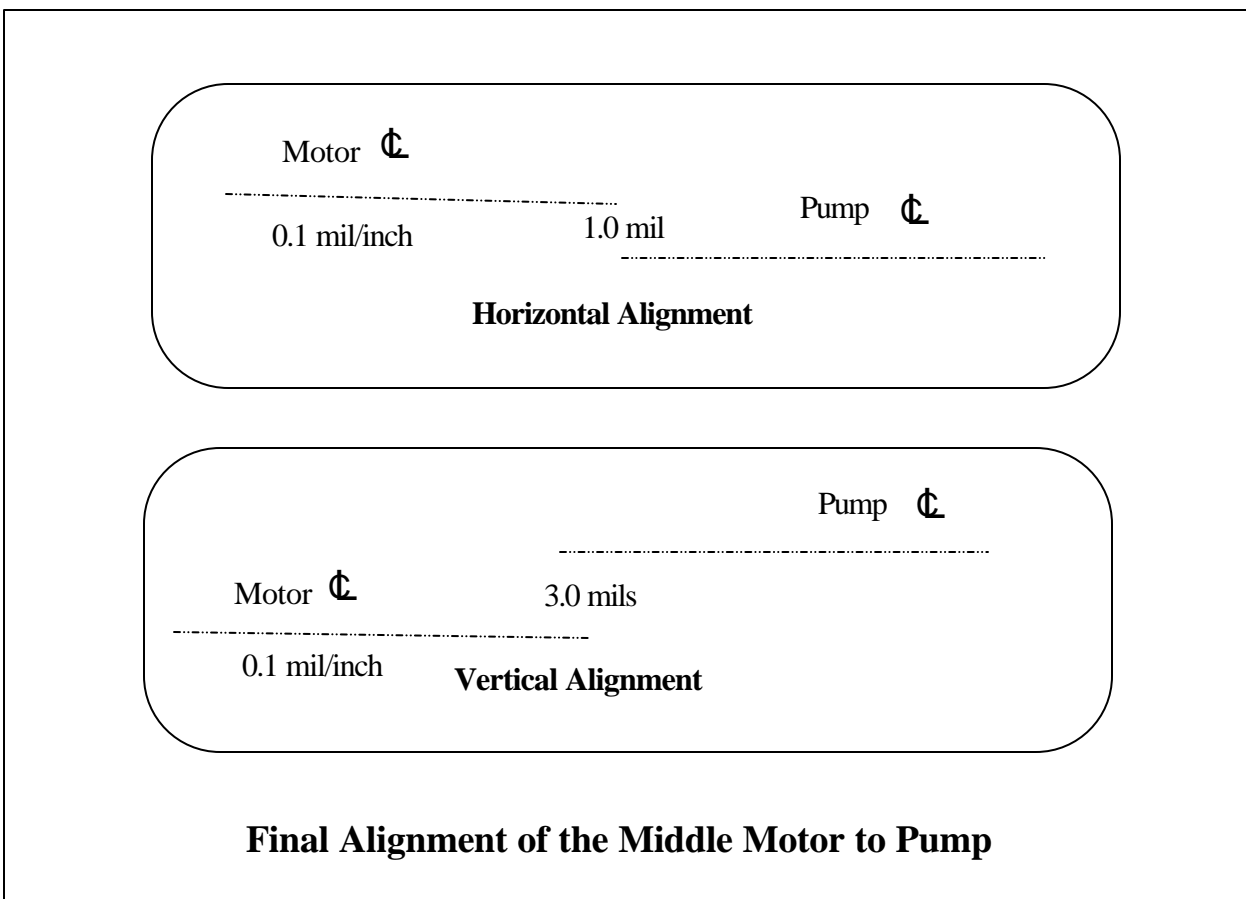
Angular soft foot of 0.005 inch was measured at the north west foot a 0.010 inch shim was cut in half transversely. The soft foot was reduced to less than 0.002 inch.

Axial gap was measured using thickness gage methods. Final axial gap was 0.135 inch.

The motor was set 0.003 inch below the pump to accommodate thermal growth of the motor in relation to the pump.

Vertical corrections were to remove 0.010 inch from both rear feet and add 0.005 inch to both front feet.

Horizontal corrections were made using the active display from the LASER.
