# Field Services Report:

## **Vibration Analysis and Alignment Check from Pump and Motor**

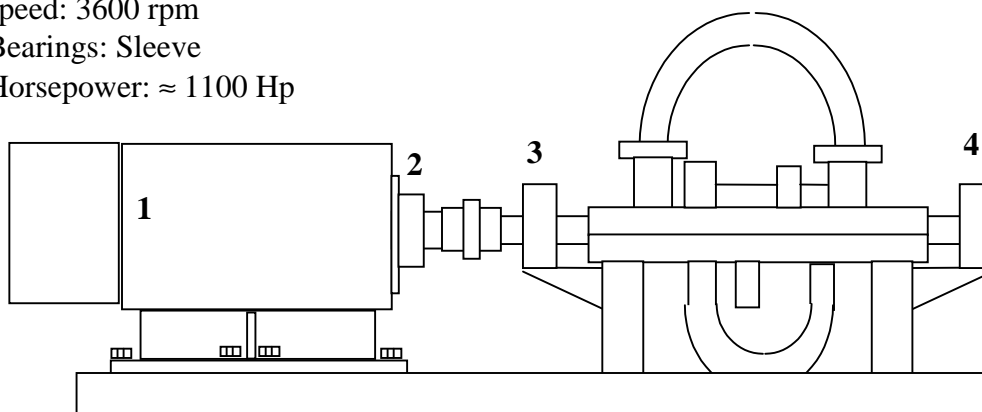
After the motor bearing temp reached about 150° F as observed from the embedded RTD sensor, vibration data was collected from the four locations in the drawing above. Horizontal, vertical and axial directions were used and several different configurations of the data collector.

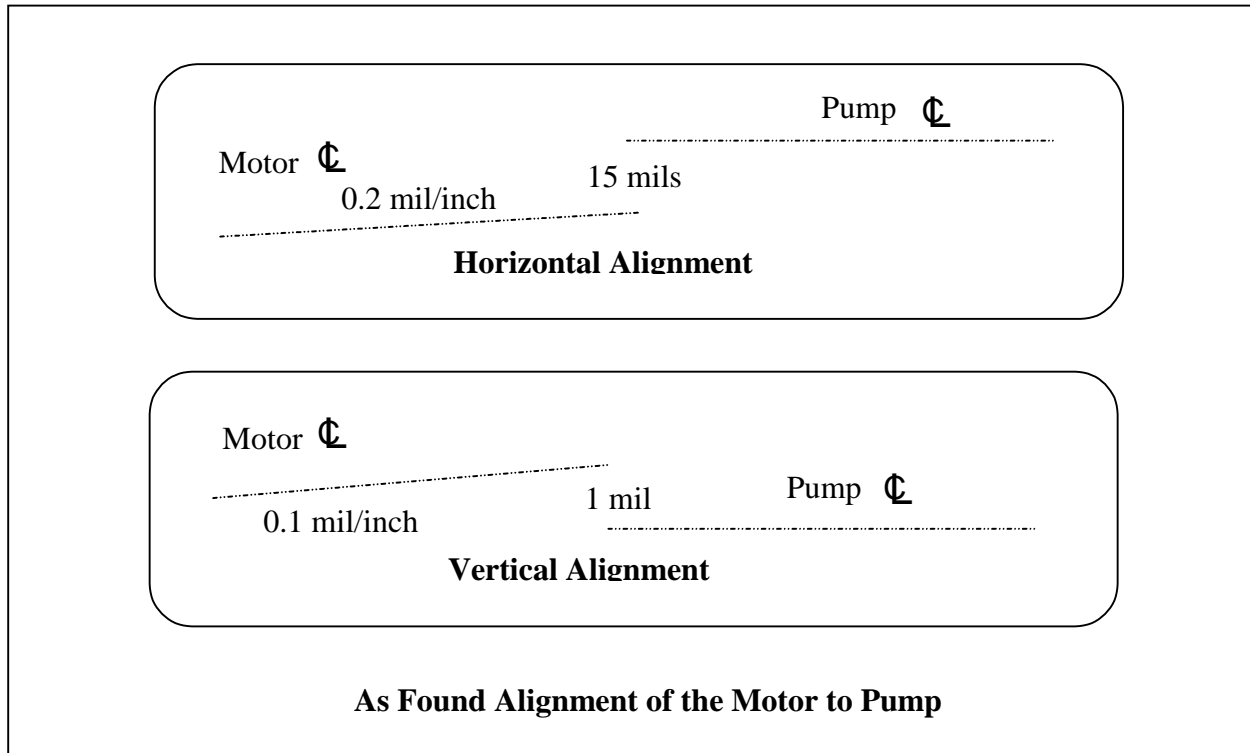
## Alignment Results

The vertical alignment is excellent. The horizontal alignment should be corrected for offset the angularity is excellent.

If the motor is going to be shimmed under the corner feet only instead of full length then the center two bolts should be removed. It was observed that the holes for mounting were elongated. Plates should be made to provide even clamping on the feet. Small washers that deform into the holes will allow the motor to shift position during operation.

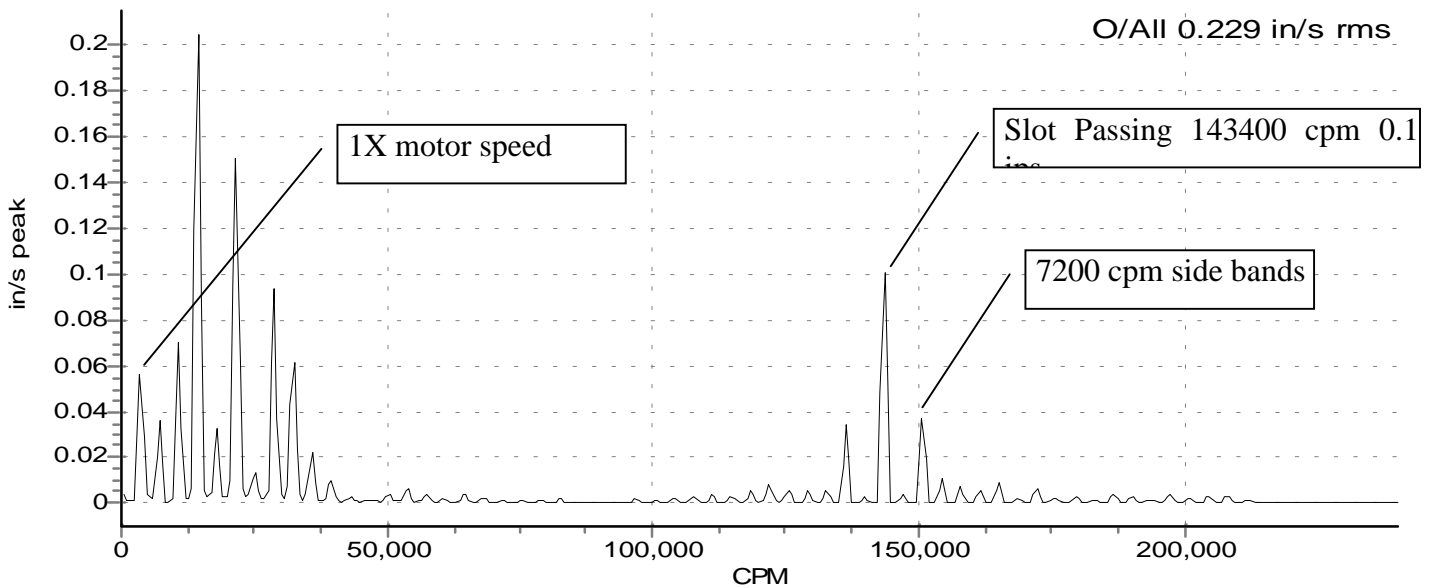
PP020122 - 123A - 2 - Horizontal - Vel Freq 240000 CPM  
1/22/2002 11:06:03 AM

The above spectrum shows that the slot passing vibration is greater in amplitude than the operating speed and that the 4<sup>th</sup> order harmonic is the highest peak. Typically there should be some slot passing vibration but not greater in amplitude than the operating speed vibration. The side bands at 2X line frequency should be very low. This demonstrates there is an electrical problem with the motor.

The motor should be tested and evaluated for broken or cracked rotor bars and shorted windings. Broken rotor bar problems are load and heat dependent. The motor should be tested under load and allowed to reach normal operating temperature.
