Field Services Report:

Relative Movement and Offset Alignment of the Carrier Chiller

While working for another firm I was asked to observe the relative movement of the components of the Carrier chiller compressor train and assist in the offset alignment. Optical and LASER methods were used.

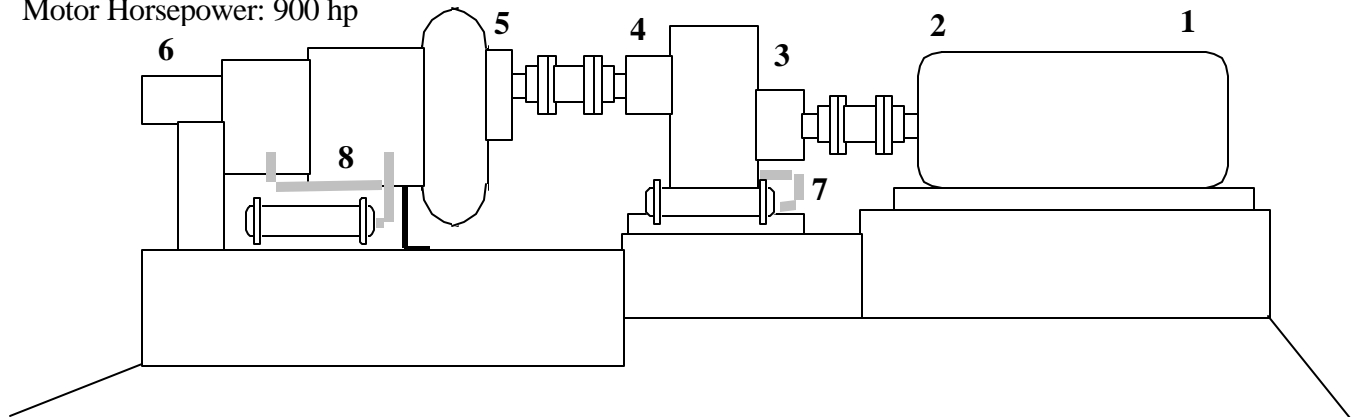
Figure 1: Machine Configuration

Foundation Type: Concrete /Structural Steel

Compressor Type: Centrifugal

Compressor Speed: 7200 rpm

Motor Speed: 1800 rpm

Motor Horsepower: 900 hp

Covered bench marks were installed at locations 1 - 6 inclusive (see figure 1).

Bench marks were installed in the concrete along the longitudinal axis of the compressor train. These were used for the horizontal reference.

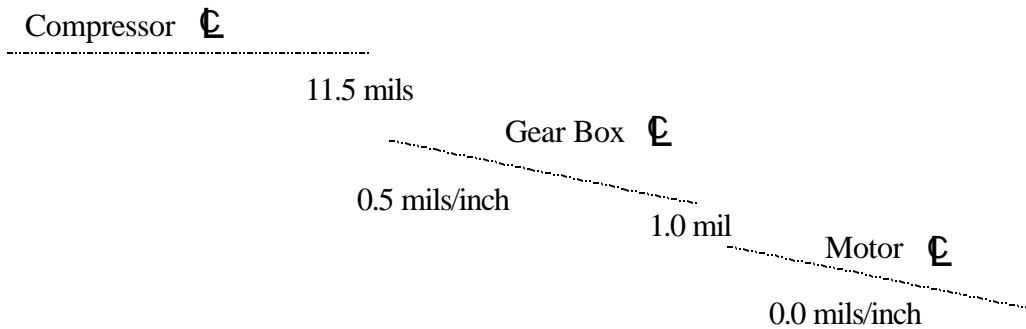
Figure 2: Horizontal Alignment

The compressor train was offset aligned using calculations from the data recorded in the previous step.

Due to the looseness of the motor only data recorded from positions 5-6 inclusive were considered valid. Calculated thermal growth offsets were used for positions 1-4 inclusive.

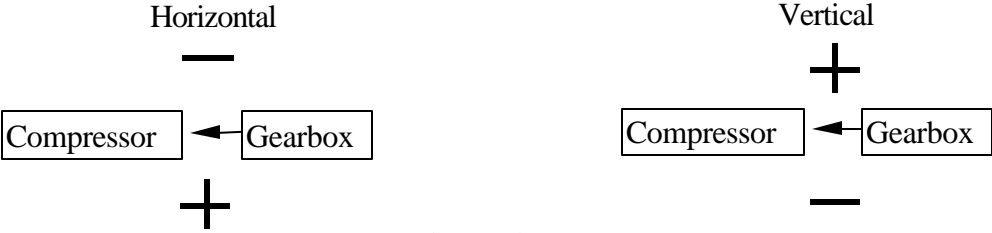
Figure 4: Movement Key

Table 2: Measured Relative Movement

POSITION	MOVEMENT	POSITION	MOVEMENT
5 horizontal	+ 0.006 inch	5 vertical	+ 0.022 inch
6 horizontal	- 0.014 inch	6 vertical	+ 0.010 inch

Table 3: Calculated Movement

POSITION	MOVEMENT	POSITION	MOVEMENT
1 horizontal	+ 0.001 inch	1 vertical	+ 0.001 inch
2 horizontal	+ 0.001 inch	2 vertical	+ 0.001 inch
3 horizontal	+ 0.002 inch	3 vertical	+ 0.005 inch
4 horizontal	- 0.003 inch	4 vertical	+ 0.007 inch

The relative movement should be observed at the next available time to measure changes associated with operational changes.
