Field Services Report

Alignment of Ball Mill Using Optical and LASER Methods

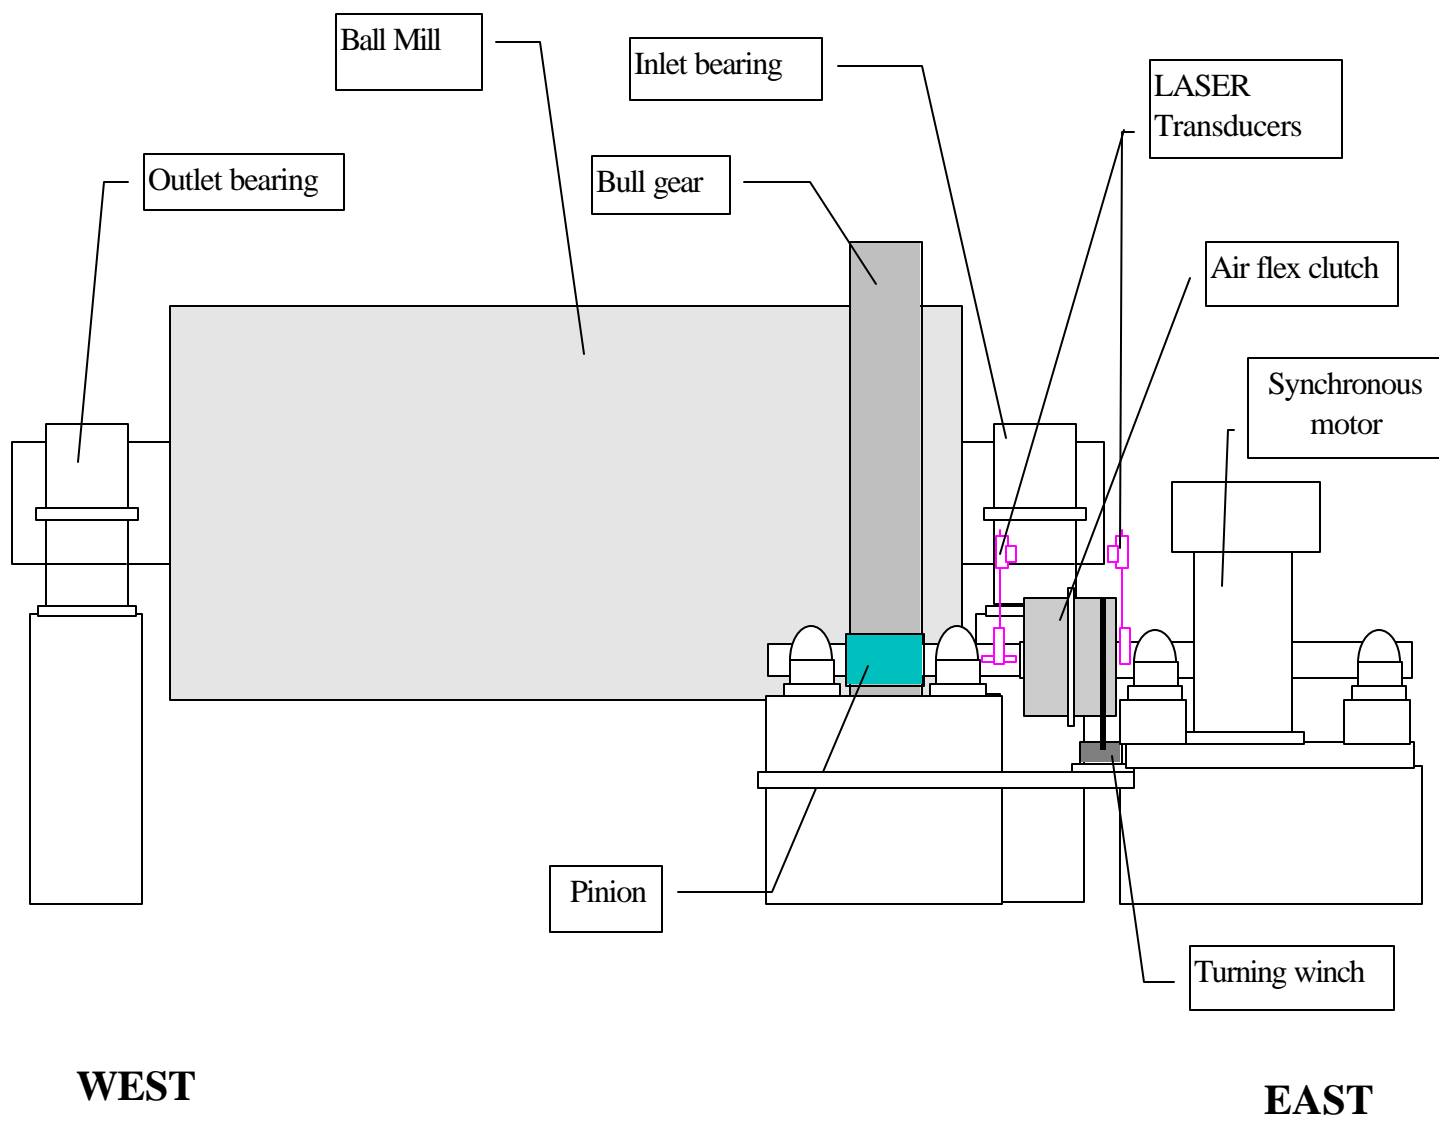
Machine Configuration

Plant personnel stated that they had been experiencing clutch failure problems due to misalignment. Three coils on the motor were bad and would be replaced during the next shutdown.

The as found alignment of the pinion to the bull gear was 0.141 inch difference east to west. The back lash was 0.035 east to west. The alignment across the clutch was 0.012 inch offset with 0.003 inch/inch angularity in the horizontal direction and 0.034 inch offset with 0.0007 inch/inch angularity in the vertical direction. An elevation difference of 0.020 inch was measured from the mill bearings.

Some spalling was visually observed on the pinion teeth on the west half of the pinion gear. This was probably from misalignment to the bull gear. An increase in vibration at the pinion bearings will result from the alignment corrections until the pinion gear wears in.

Vertical Corrections: 0.025 inch of full length stainless shim was added under the east pinion bearing. 0.020 inch of full length stainless shim was added under the west pinion bearing.
