# Field Services Report

## Vibration Analysis: Rental Boiler FD Fan

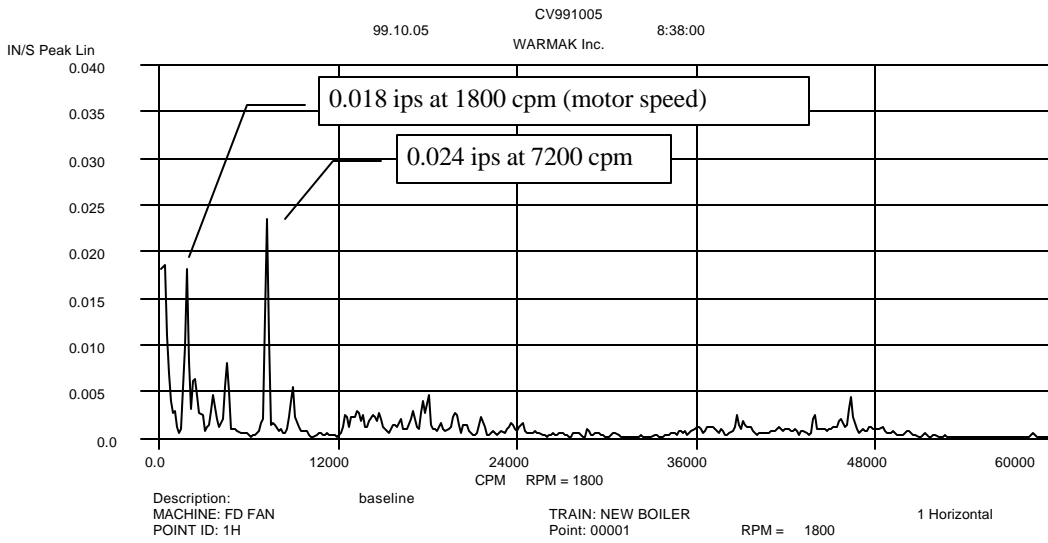
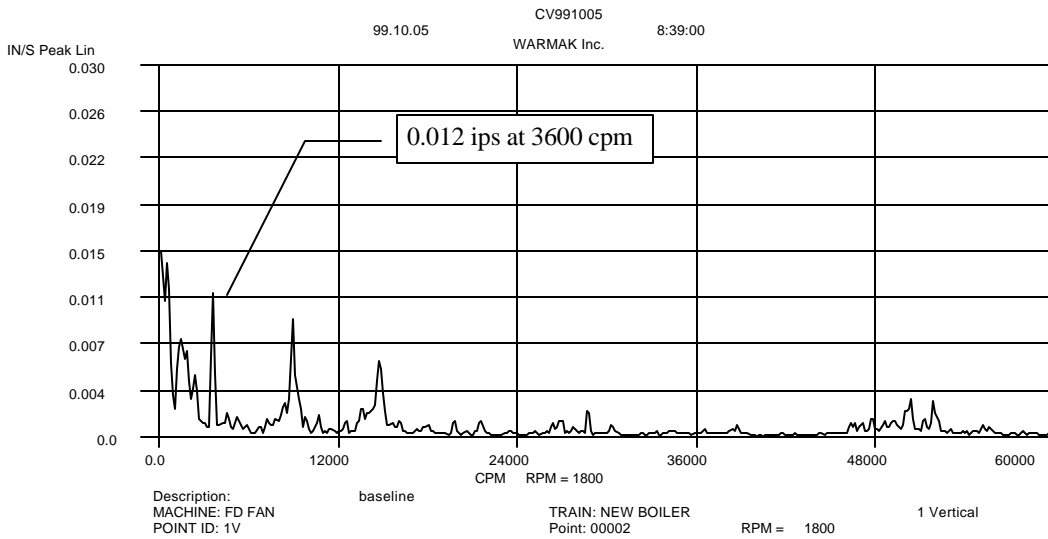
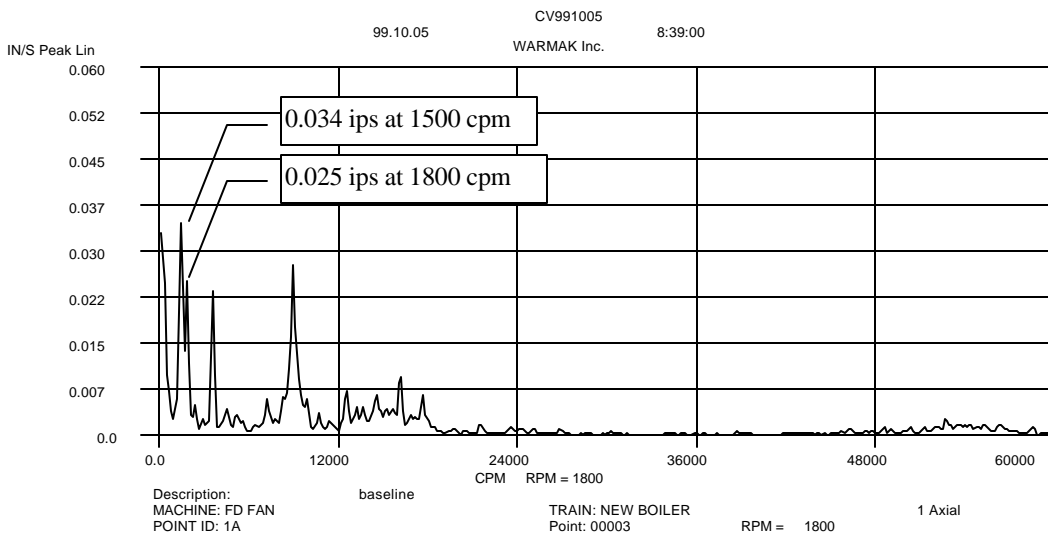
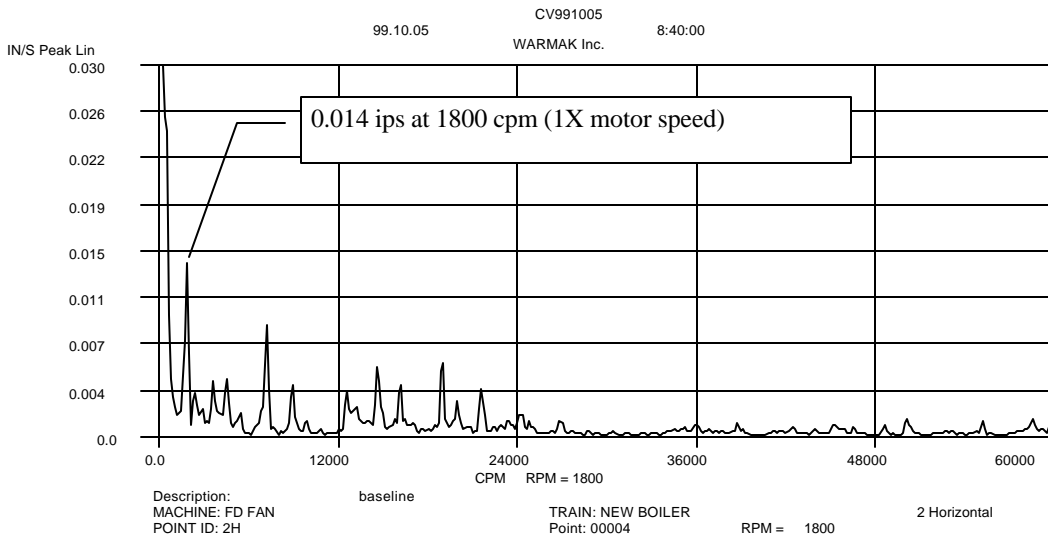
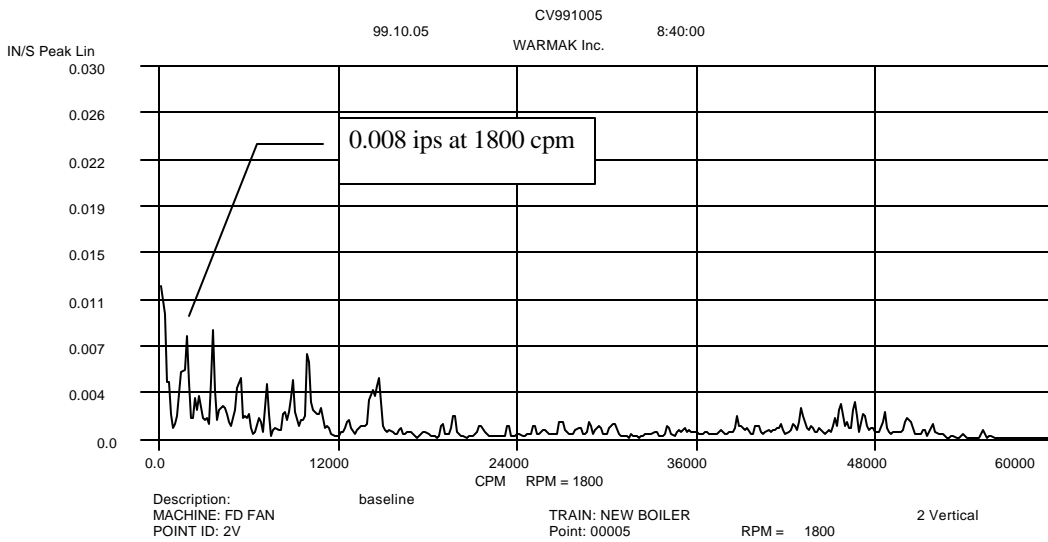
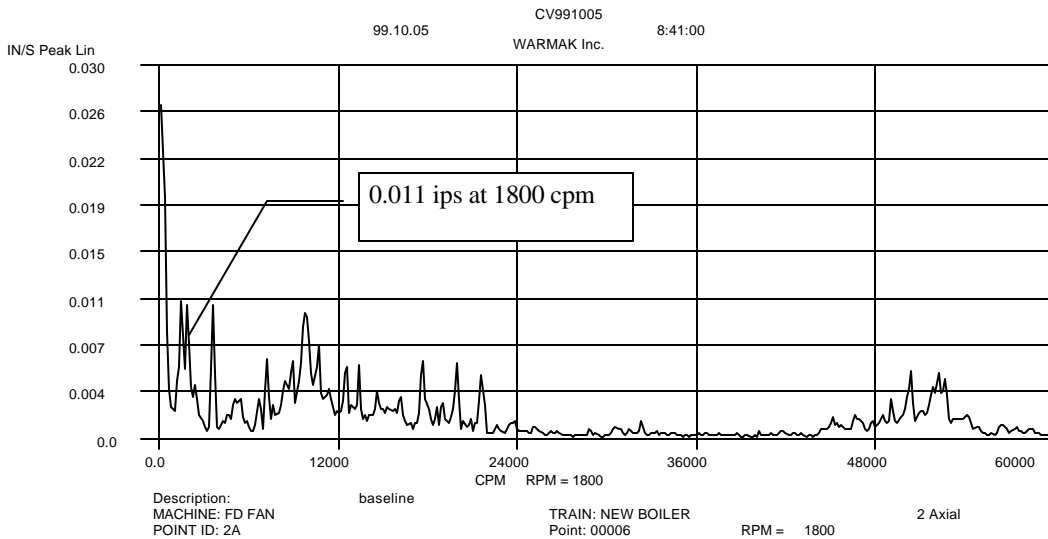
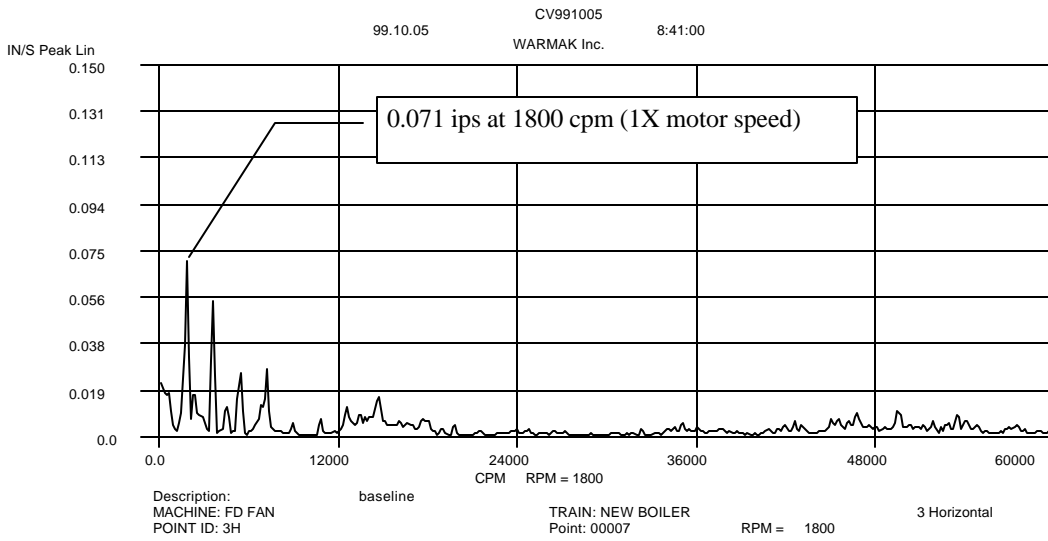
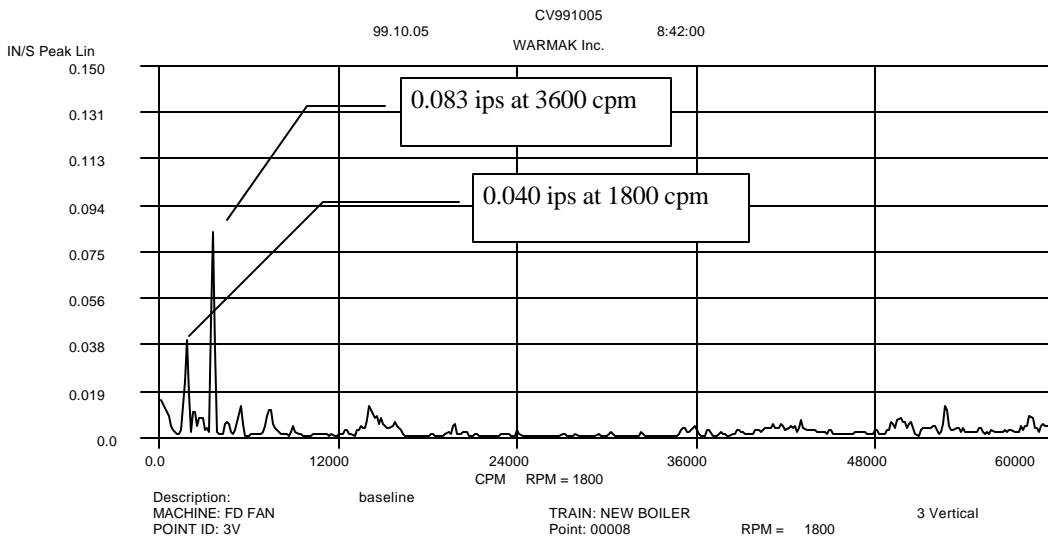
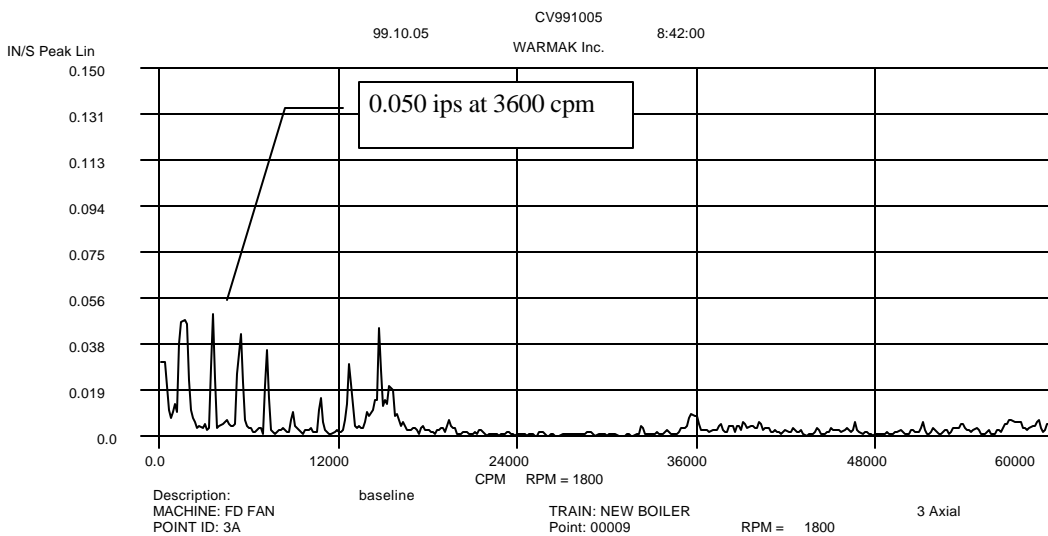
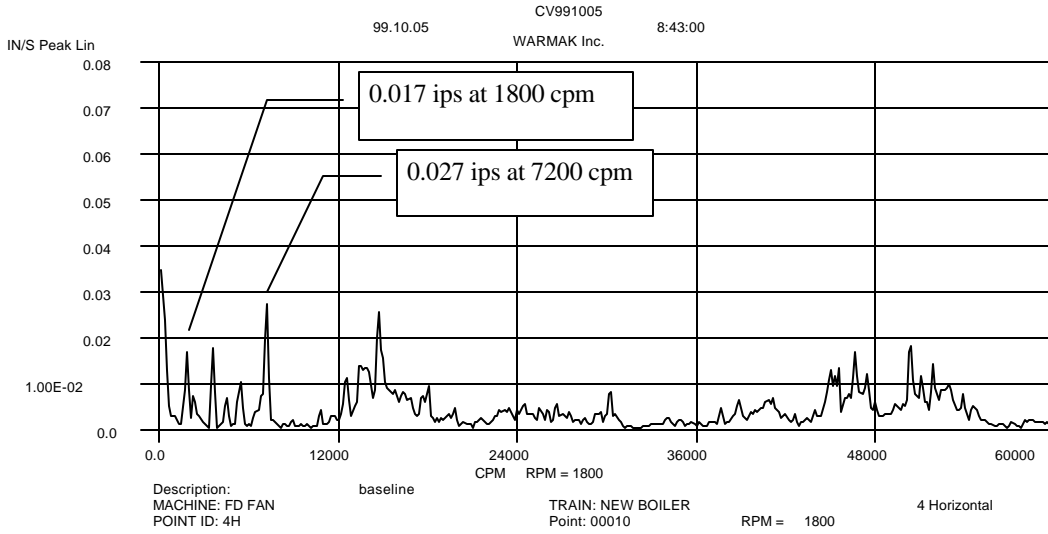
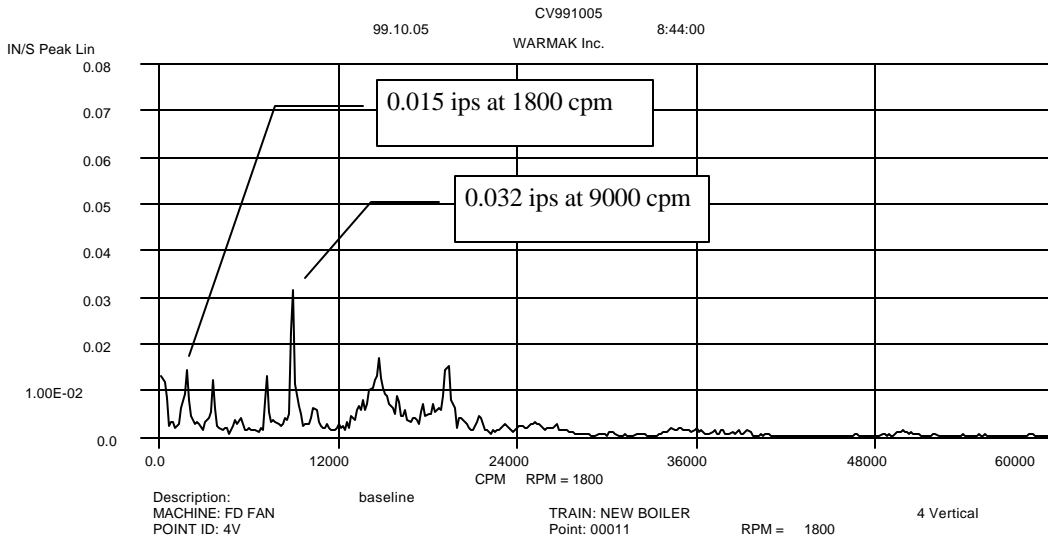
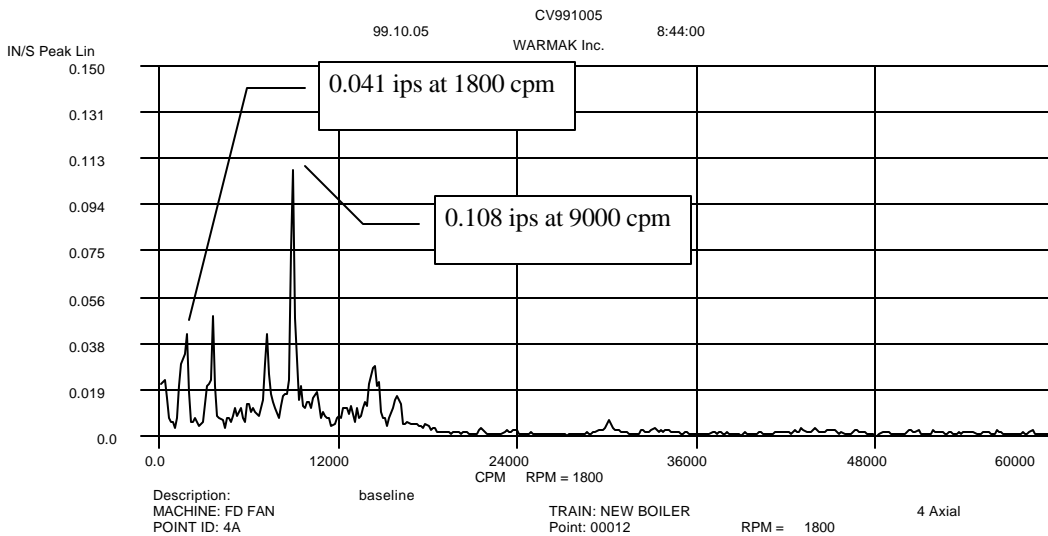
**Fresh Air 45%, Recirculated Air 60%**

Position	Amplitude	Frequency	Date
1H	0.018	1800.00	99.10.05
1V	0.012	3600.00	99.10.05
1A	0.034	1500.00	99.10.05
2H	0.014	1800.00	99.10.05
2V	0.008	1800.00	99.10.05
2A	0.011	1800.00	99.10.05
3H	0.071	1800.00	99.10.05
3V	0.083	3600.00	99.10.05
3A	0.050	3600.00	99.10.05
4H	0.027	7200.00	99.10.05
4V	0.032	9000.00	99.10.05
<b>4A</b>	<b>0.108</b>	<b>9000.00</b>	<b>99.10.05</b>

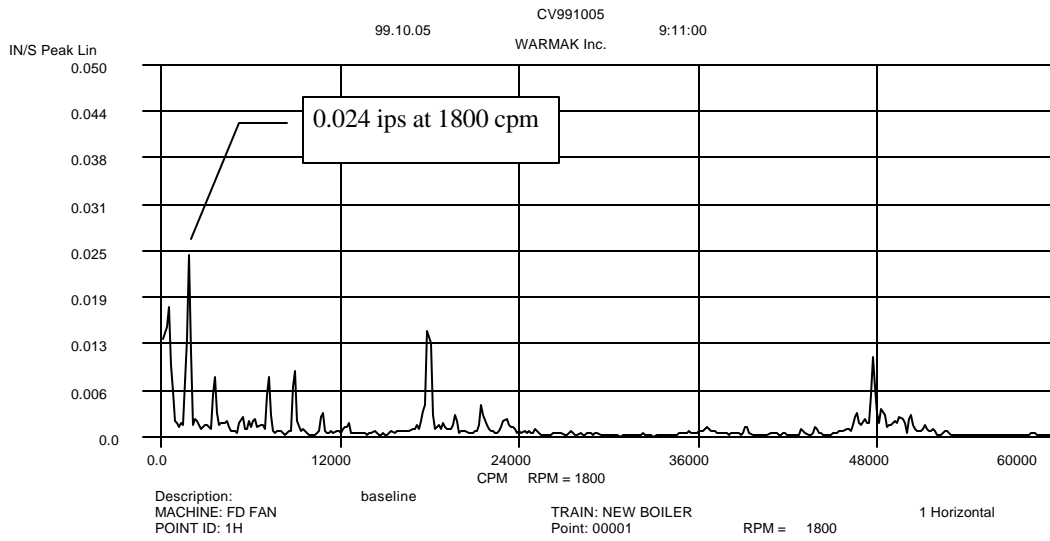
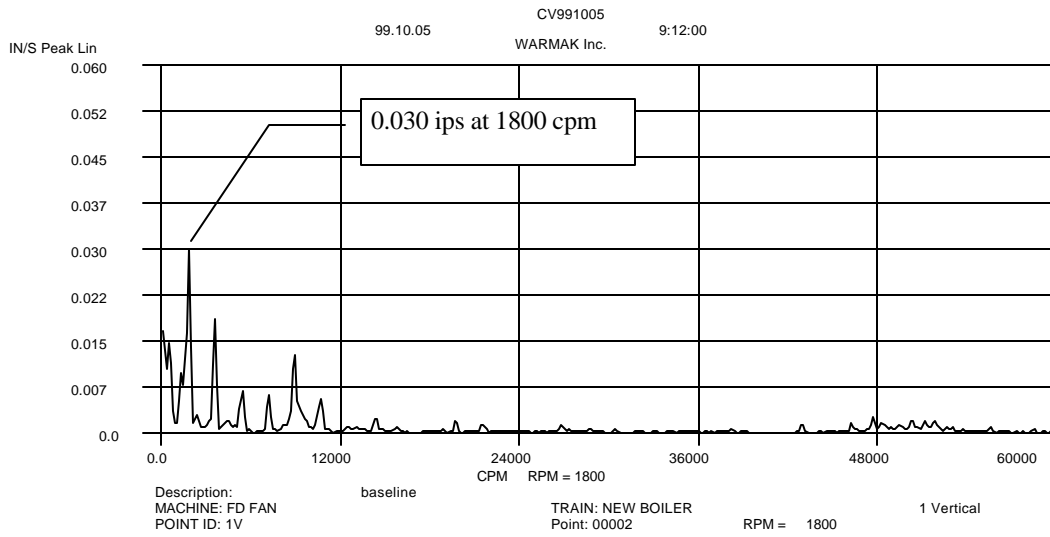
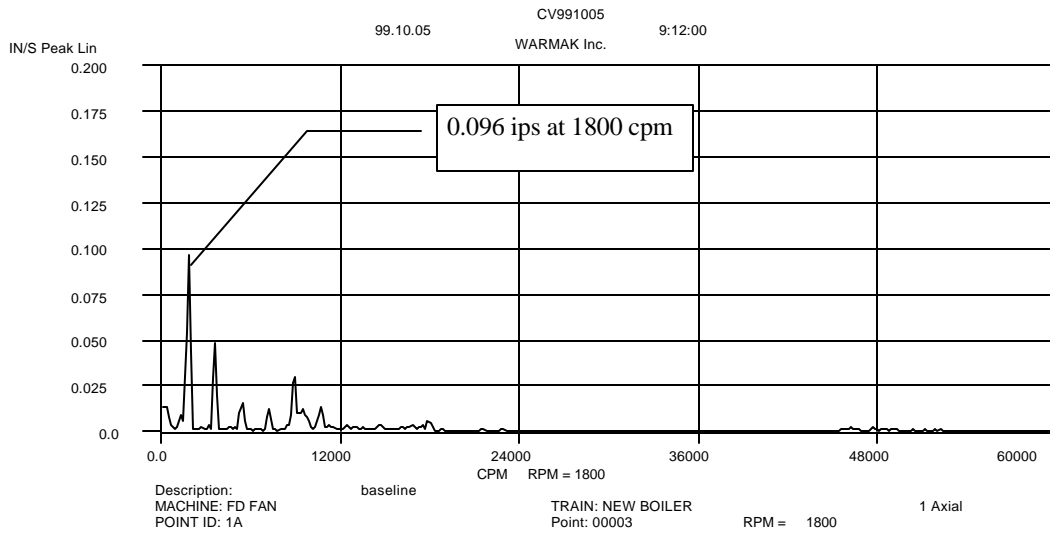
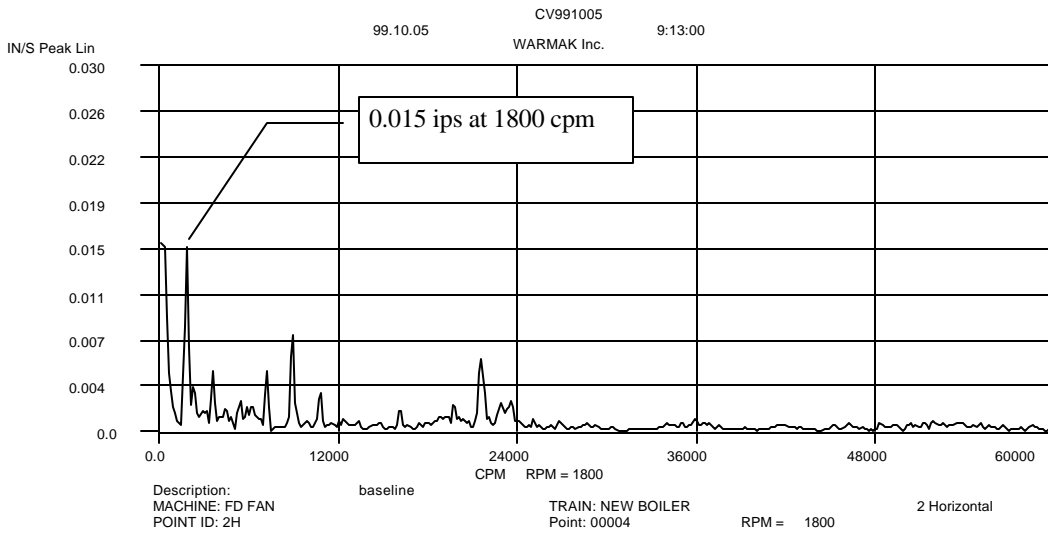
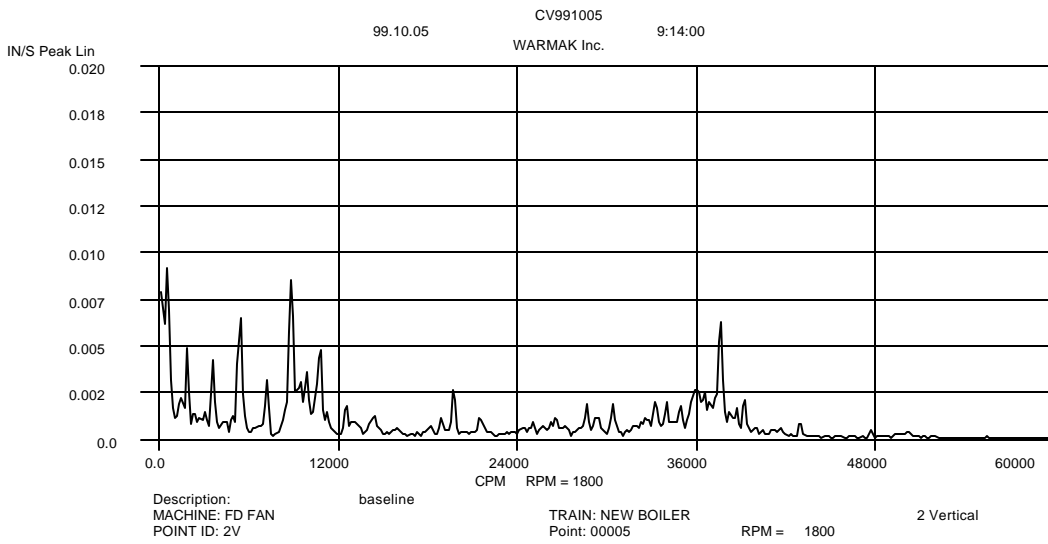
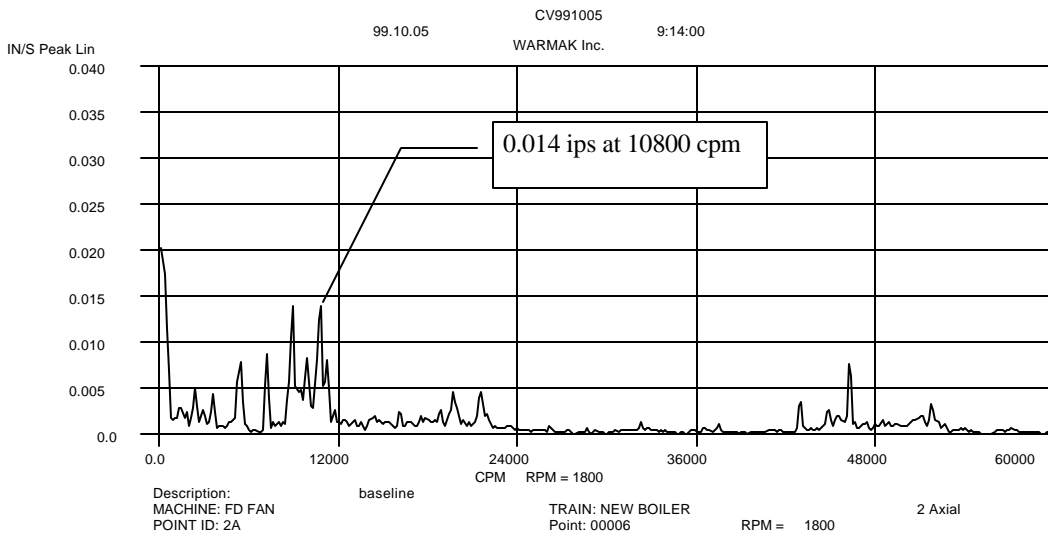
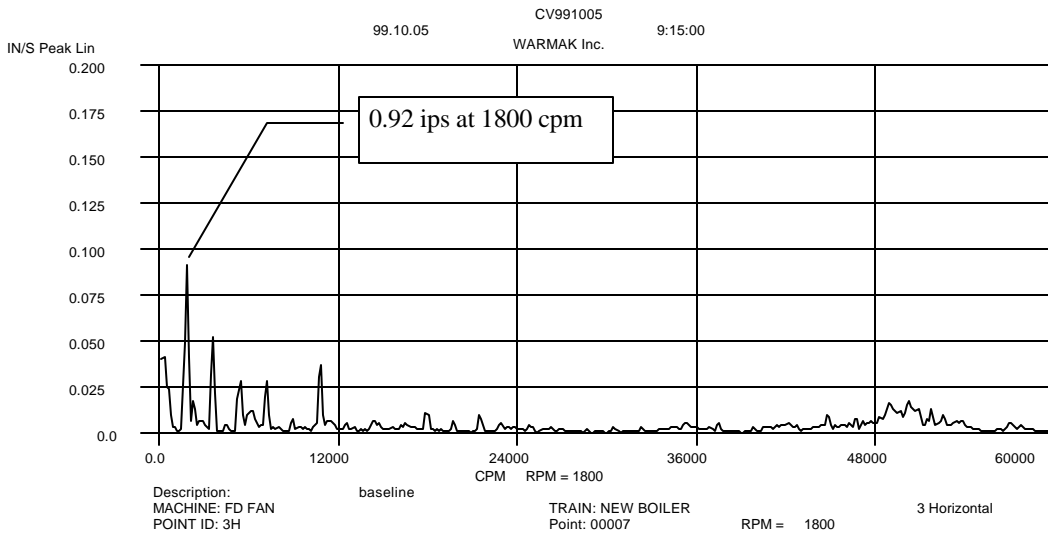
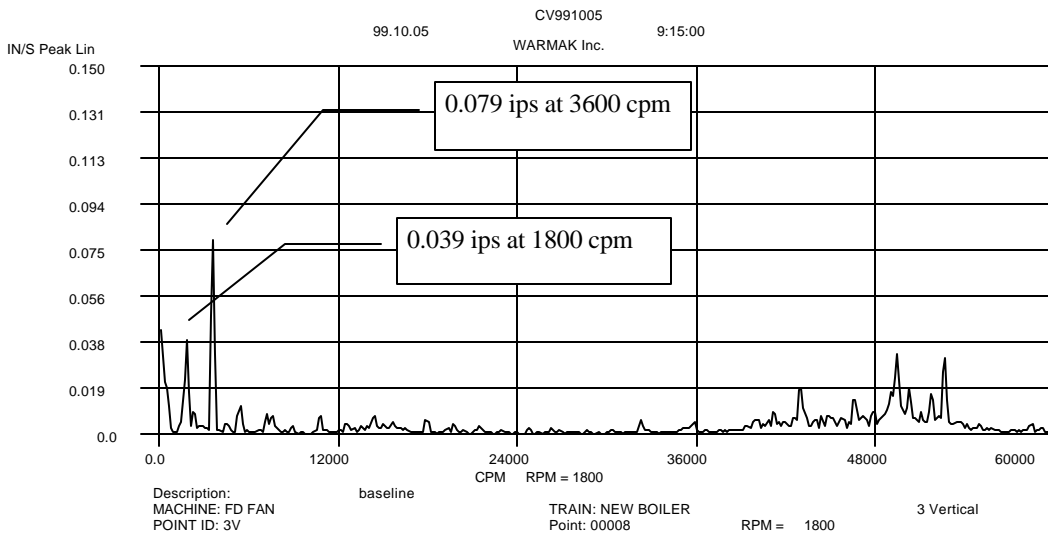
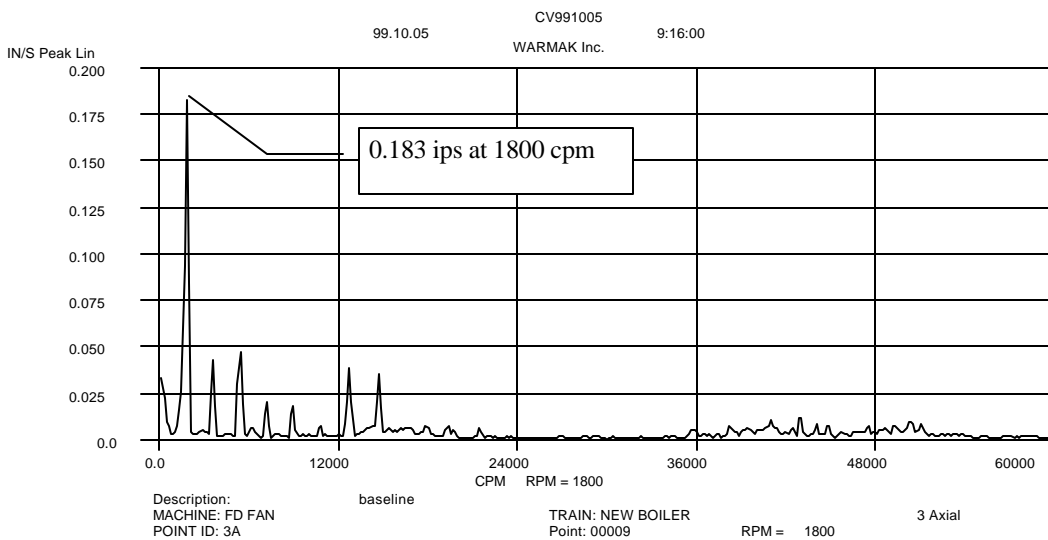
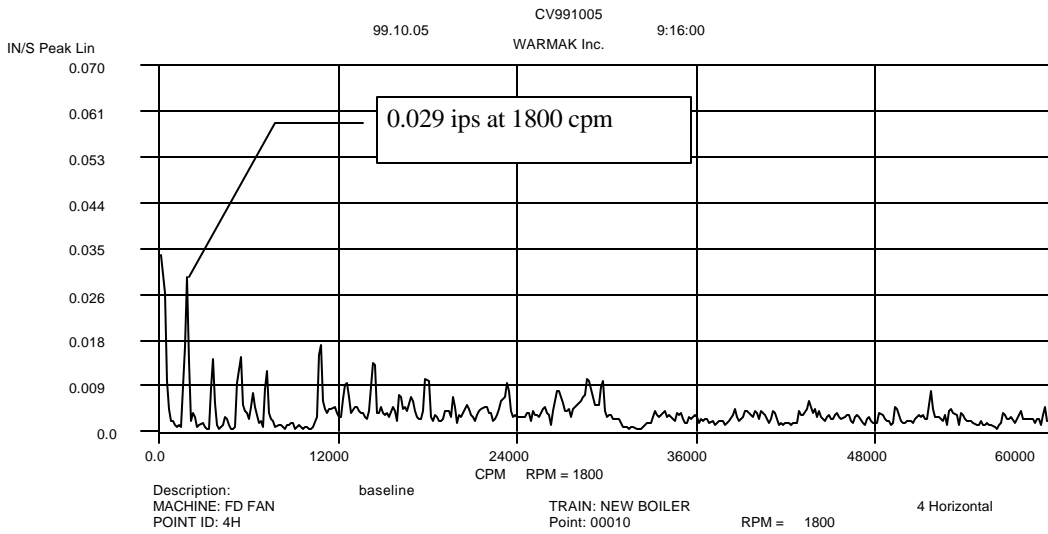
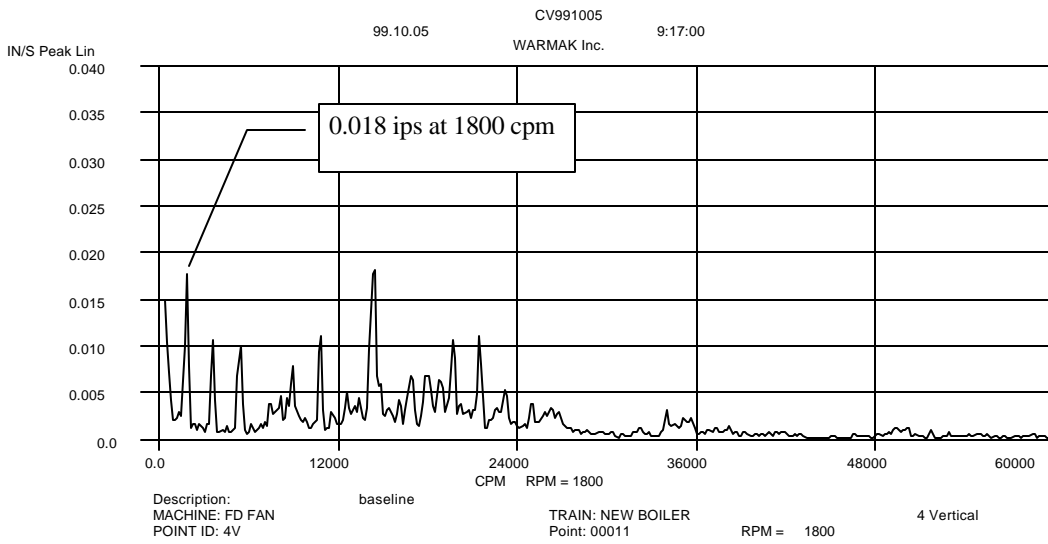
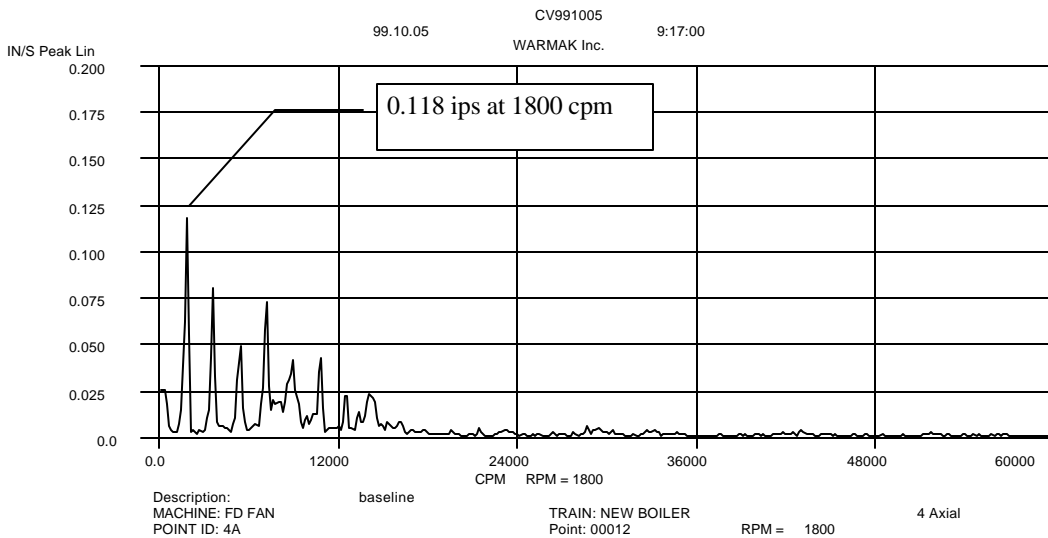
**Fresh Air 100%, Recirculated Air 80%**

Position	Amplitude	Frequency	Date
1H	0.024	1800.00	99.10.05
1V	0.030	1800.00	99.10.05
1A	0.096	1800.00	99.10.05
2H	0.015	1800.00	99.10.05
2V	0.005	1800.00	99.10.05
2A	0.005	1800.00	99.10.05
3H	0.092	1800.00	99.10.05
3V	0.079	3600.00	99.10.05
<b>3A</b>	<b>0.183</b>	<b>1800.00</b>	<b>99.10.05</b>
4H	0.029	1800.00	99.10.05
4V	0.018	1800.00	99.10.05
4A	0.118	1800.00	99.10.05
