# Field Services Report:

## **Vibration Analysis and Alignment Check from Pump and Motor**

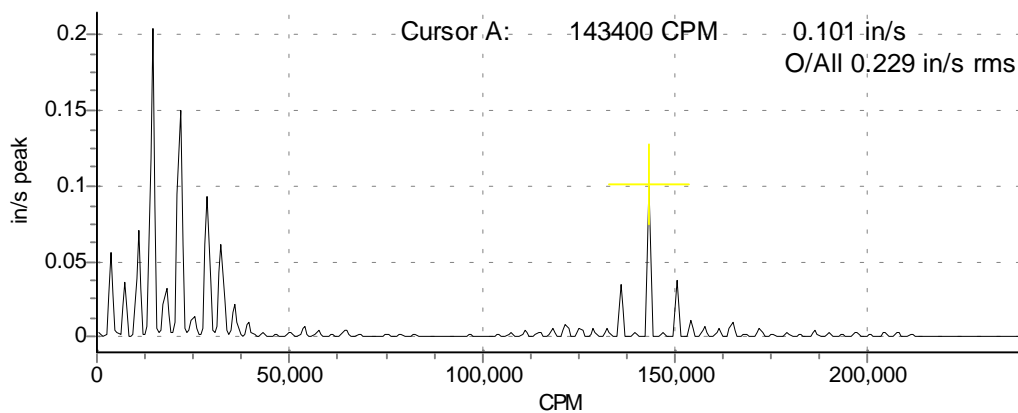
PP020122 - 123A - 2 - Horizontal - Vel Freq 240000 CPM  
1/22/2002 11:06:03 AM

The above spectrum shows that the slot passing vibration is greater in amplitude than the operating speed and that the 4<sup>th</sup> order harmonic is the highest peak. Typically there should be some slot passing vibration but not greater in amplitude than the operating speed vibration. The side bands at 2X line frequency should be very low. This demonstrates there is an electrical problem with the motor.

The motor should be tested and evaluated for broken or cracked rotor bars and shorted windings. Broken rotor bar problems are load and heat dependent. The motor should be tested under load and allowed to reach normal operating temperature.
